## 5. Arrow Valley Catchment Restoration Project (Pages 1 - 40)

Water Safety Review for:  
**Redditch Borough Council**

**April 2014**

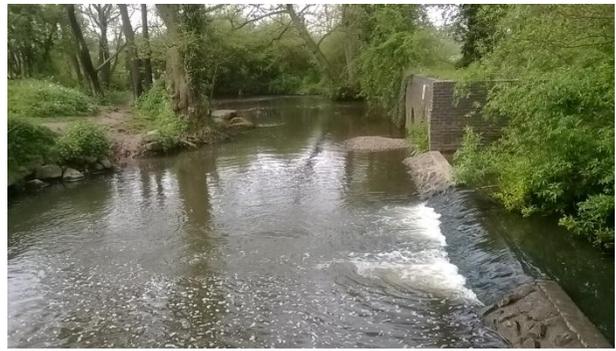
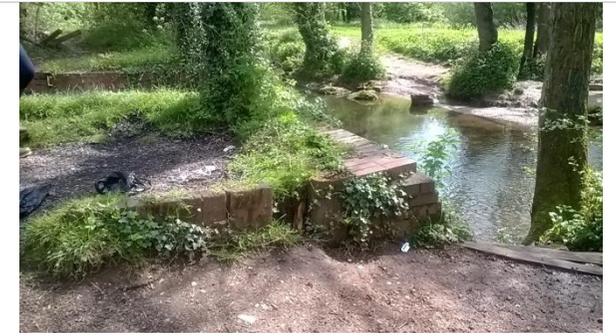
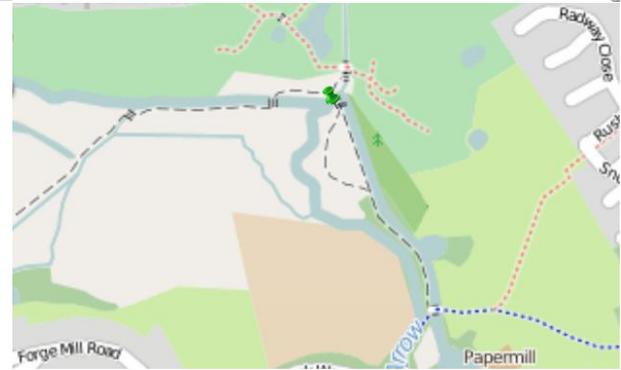
**Five Tunnels (#1)** had multiple hazards in close proximity including a weir, sluice and is a known swimming spot. There is also signs of vandalism/fire and alcohol use. In addition to the water hazards, falls from height into water/objects is a significant factor at this location.

Other comments: Difficult site to effectively mitigate. Need to consider access from both waterside meadow (RL top image) and through fence on RR (Second image). Slip/Trip/Fall scenarios are more likely to be realised than swim/in water harm at this location.

- (i) Steps STF on RL
- (ii) Height and remains of sluice structure.
- (iii) Signs of alcohol use adjacent to sluice.

Mitigation options: (i)S/M term: maintain monitoring and information regime. (ii) Longer term: Possible package of work to re-profile weir and sluice.

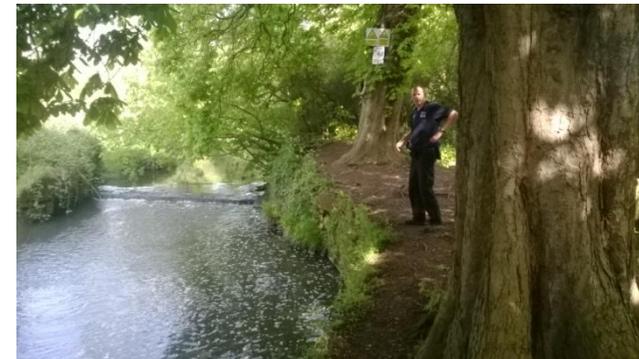
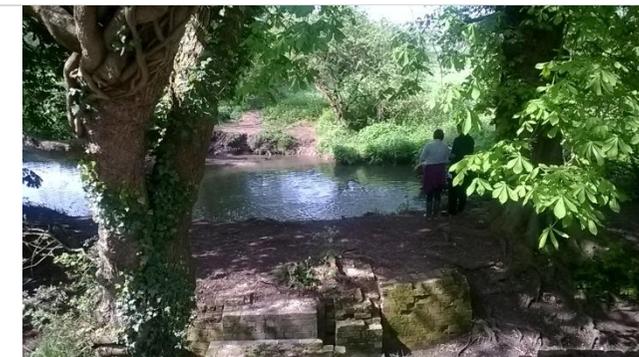
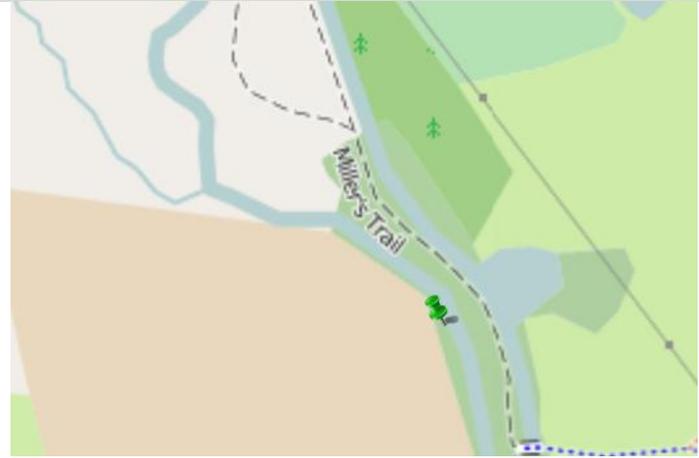
**# 3** Paper Mill Weir, River Arrow CP, Redditch

**Paper Mill Weir (#3 and Appendix 1)** is the scene of the last fatality and has a history of significant near misses. The combination of flowing, recirculating cold water, steep sided walls and very easy access from the footpath and main entrance points combined, with the presence of a weir and what - on the surface - looks to be a benign swimming/play spot, rates as a 'High risk' location. Further, at this location there are numerous slip/fall hazards: a broken leg or serious impact injury is also very likely.

- (I) Numerous STF features i.e. Roots, old brickwork, mixed ambient lighting.

Mitigation options: S/M term: Install barriers from footpath, indicate change in area from path. Possible PRE + Interpretive signs (see discussion). Long term: Package to re- profile location.

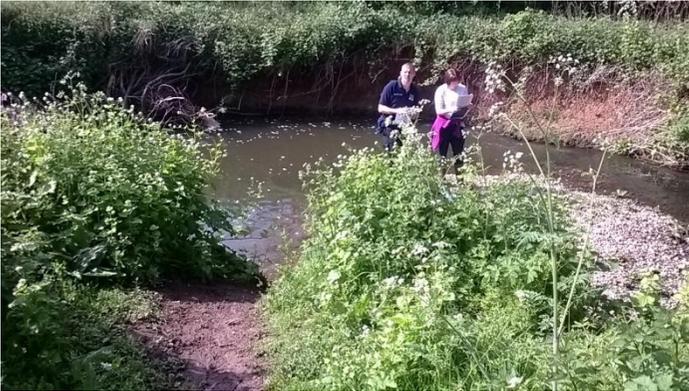
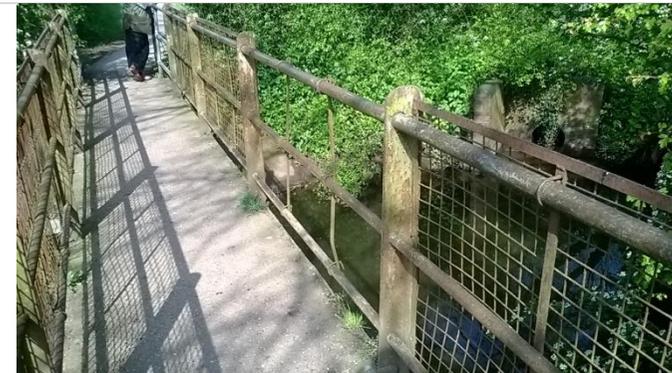
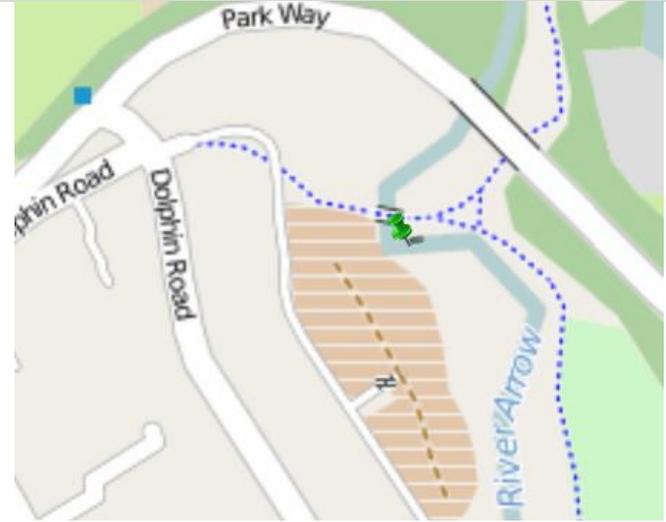
**# 4**      **Abbeydale (Dolphin Rd Allotments), R.Arrow**

Other comments: Works planned (County Council) to upgrade bridge. At high water levels, bridge is partly covered.

- (i) Footbridge missing infill section, barrier still intact.

Mitigation options: (i) Periodic monitoring and snag fixes. (ii) Watercourse clearing as part of flood mitigation approaches. (iii) Bridge snag/repair.

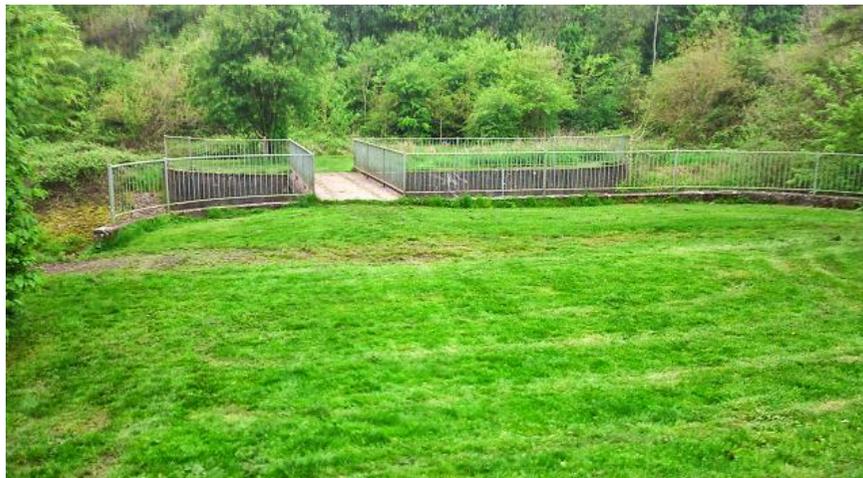
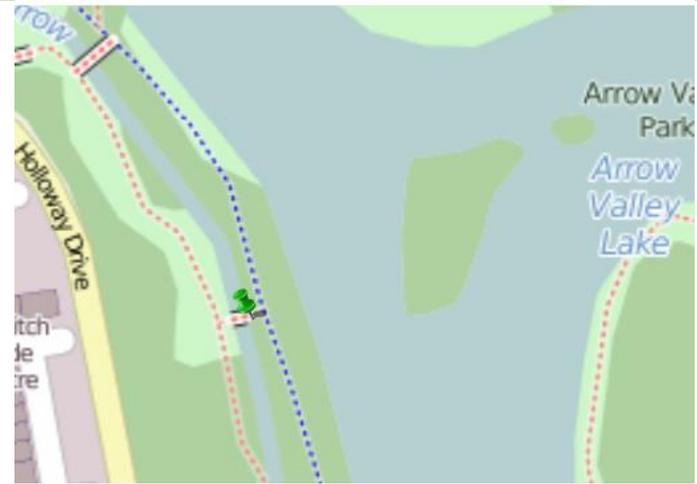
**# 8 Middle Weir, R. Arrow CP**

Other comments: No swimming sign not present - logical as no sign of swimming at this location verses Lower Weir. All three weirs should be considered as part of possible engineering package. Note: Assessment of risk will change in higher/rising levels. Most likely that key at risk group are staff assessing/maintaining.

Mitigation options: S/M term: Monitor. Long term: Remove as part of wider package of work to remodel flow and reinstated natural flow section using nearby brook.

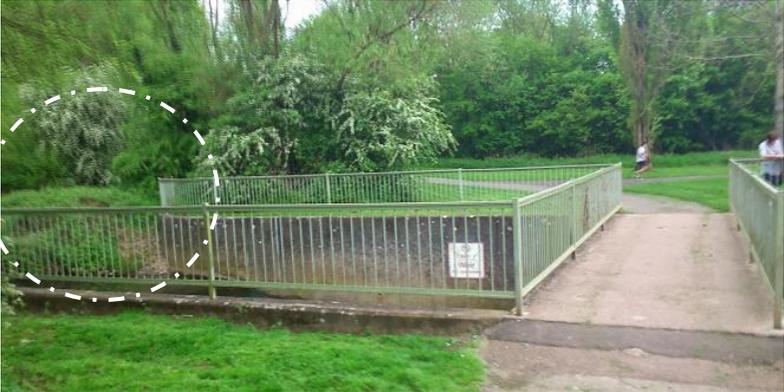
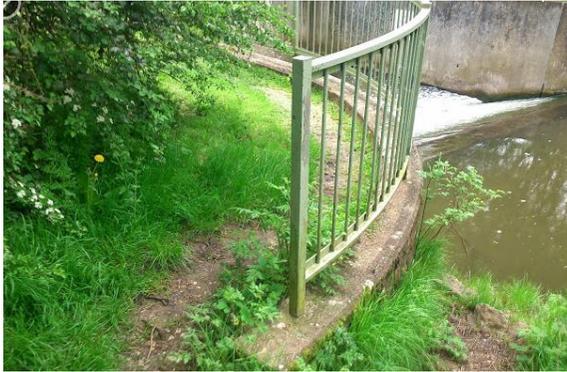
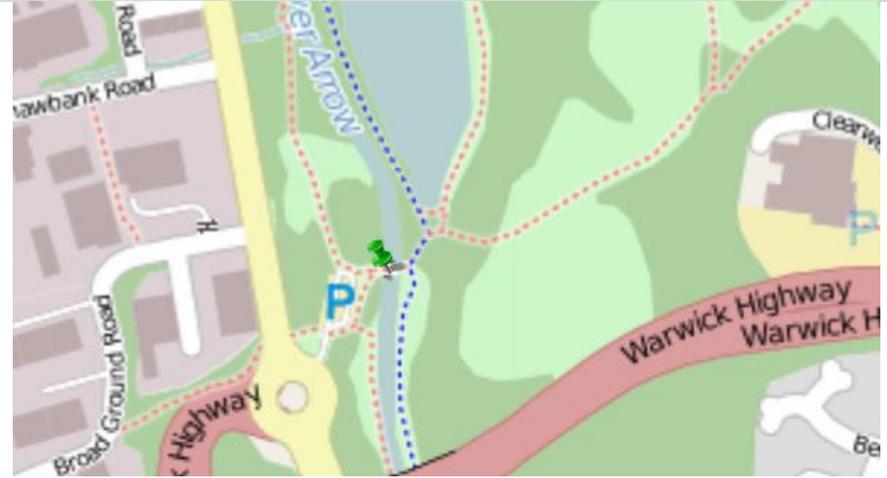
**# 8.1 Lower Weir, R. Arrow, Near Broad Ground CP**

**Lower Weir' (#8.1)** at a score of 67 is on the cusp of a 'High risk' location rating; this is due to the presence of teenagers and use in the locality, aligned with potentially dangerous water conditions. Weirs can present unique challenges due to the non-obvious recirculating nature of the currents, further they can and do regularly escalate into multiple casualty events.

Description: Enclosed triangular weir with approx 2500mm concrete freeboard, surrounded by 1100mm flared balustrade. Access via 'Broad Road' car park or SE lake footpath. Bridleway adjacent to location leading towards basketball court and underpass, and housing estate. Weir is 3 of 3 along this linear stretch originally designed to take energy out of the river along this canalised section. Lots of footfall over bridge and signs of play at both RR downstream bank and critically RL upstream (above lip circled). Graffiti and worn areas (see images). No swimming sign and known (?) swimming spot.

Other comments: *Potentially very dangerous hydraulic at key water levels,* somewhat mitigated by bad weather. Worth assessing during/after peak flow to assess hydraulic risks. Critical period will be after higher water condition and nicer weather i.e. Visitors back on site immediately after rainy days. Note staff/maintenance risks as per middle weir.

**Principle hazards observed**  
Water  
 (i) Hydraulic jump ('slot') at critical (undetermined) water levels.  
 (ii) Depth and current below hydraulic  
 (iii) Temperature  
 (iv) Recirculating currents

Other  
 (i) Fall hazard on RR downstream wall (end of barrier).

Mitigation options: S/M term: Encourage no access marginal planting at upstream RL bank. Long term: Remove as part of wider package of work to remodel flow and reinstated natural flow section using xxx brook.

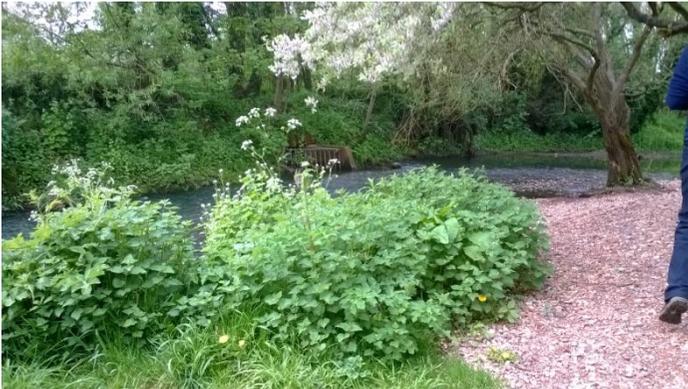
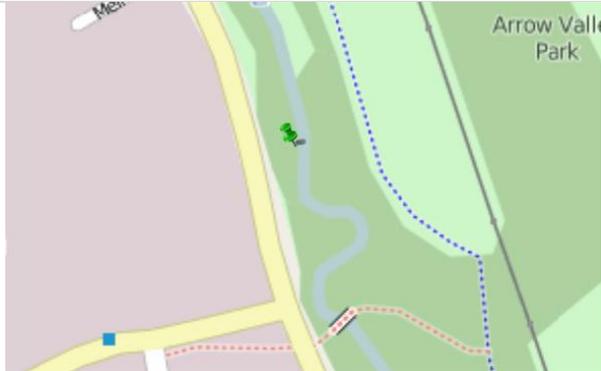
**# 10 'Beach' South of Ipsley Pool**

'Ispley Beach' (#10) scores 61, this is mostly due to the obvious presence of visitors at the location, the environment on the review day was relatively benign due to shallow gradients, good site vista and hazards that can be seen/understood by most visitors.

Description: Dogleg section of River Arrow. Path leading down to beach/wooded area. River doglegs through some 70degrees in section. Steep bank on RR, beach on RL. Pools of deeper water with base current through, fallen trees and obstruction above and below waterline. Pleasant 'beach' space above with (which will flood?) during higher flows. Known play, visit and swimming spot. Close to bridleway and route to pool.

**Principle hazards observed**  
Water  
 (i) Deeper, flowing water  
 (ii) Temperature  
 (iii) Obstruction above/below waterline

Mitigation options: (I) Ongoing monitoring (ii) Clearing watercourse (iii) Possible education / interpretive information i.e.. You are here.

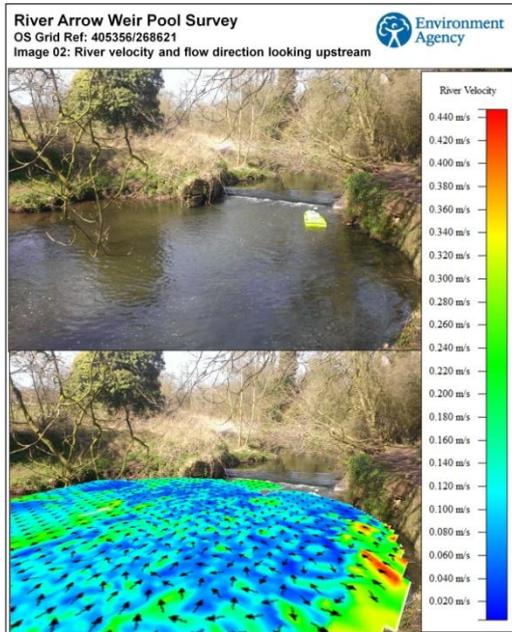
This shows the average velocity at any given point. Velocities are generally relatively low, apart from a section on the near bank which is approaching 0.45 m/s. The arrows show evidence of considerable radial flow patterns (backwards and circular flows), especially so on the bank near the camera. The highest measured velocity is directed backwards towards the weir.

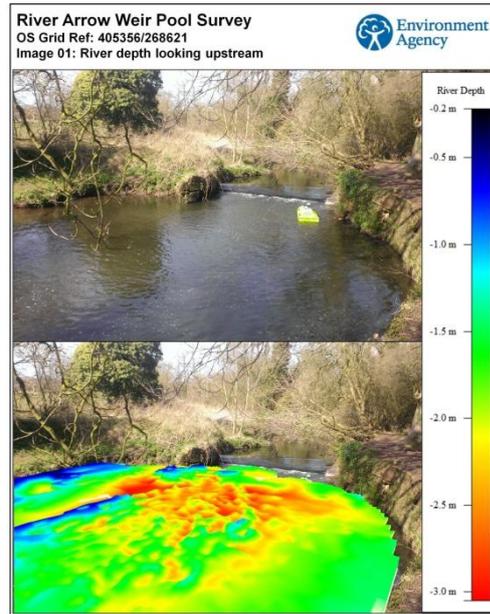
The river seems relatively benign, however the depth in the weir pool exceeds 3m with some particularly deep voids in the river bed. Within the visible section in image 1, the river is generally deeper than 1.5m however there is a narrow section (well away from the banks) which is perhaps only knee deep and then falls away into a 3m deep pool on approach to the weir.

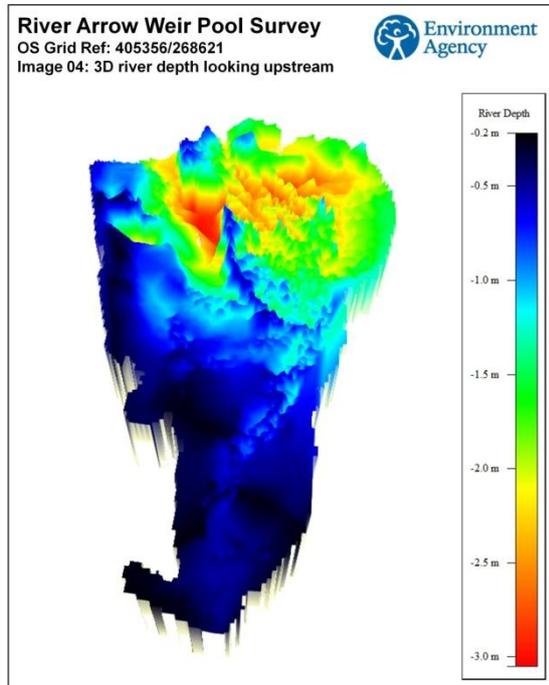
This is a 3D view looking upstream. Again it shows the relatively shallow water at the downstream entry point with deep water in the weir pool.

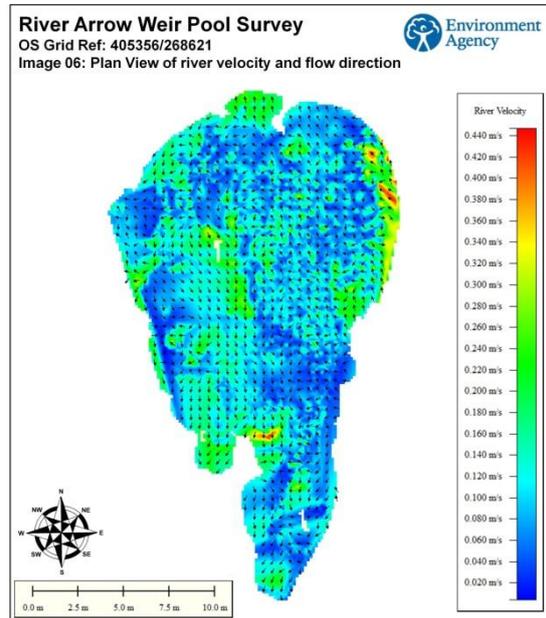
This a plan view (looking down from above) showing the river velocity and direction. It shows evidence of a very confused flow pattern in the deep weir pool. The arrows should generally align in the direction of the river flow (as they do in the bottom half of the image), however in the weir pool the river is demonstrating whirl pool characteristics with no clear direction of travel. The radial flow patterns show a re-circulation back towards the weir, and the force of this would likely attract floating objects back towards the weir.
