**The Royal Society for the Prevention
of Accidents**

Water Safety Review for:
Redditch Borough Council

April 2014

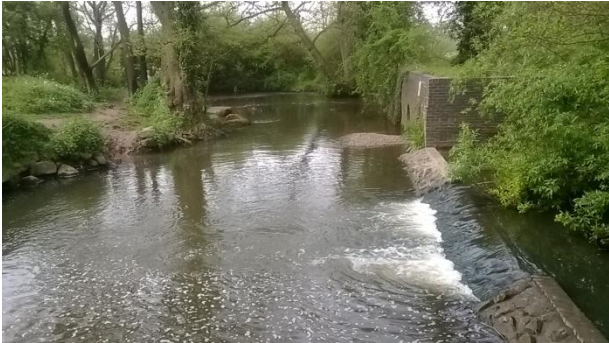
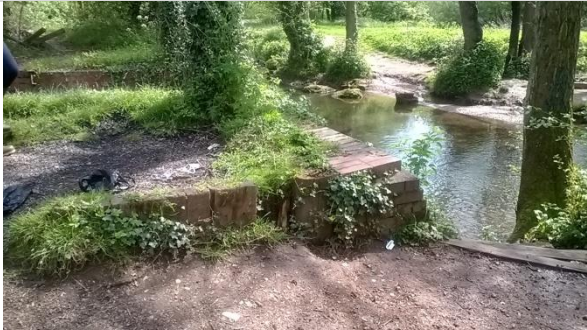
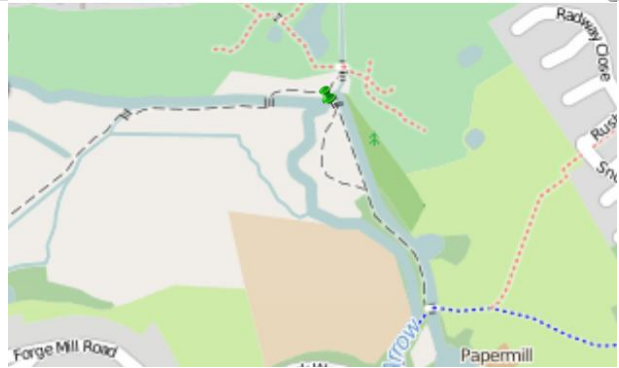
Five Tunnels (#1) had multiple hazards in close proximity including a weir, sluice and is a known swimming spot. There is also signs of vandalism/fire and alcohol use. In addition to the water hazards, falls from height into water/objects is a significant factor at this location.

# 1	Five Tunnels, River Arrow CP, Redditch		High	70
<p><u>Description:</u> Meandering - dogleg - section of River Arrow adjacent to footpath and meadow area used for picnics. Signs of fire and vandalism and known play/swim spot. Sluice and weir in s-bend, deep water sections. Part of SAM designated area.</p> <p><u>Incident history:</u> Inconclusive. Probable high use and low confidence of reports.</p> <p><u>Mitigation options:</u> (i)S/M term: maintain monitoring and information regime. (ii) Longer term: Possible package of work to re-profile weir and sluice.</p> <p><u>Other comments:</u> Difficult site to effectively mitigate. Need to consider access from both waterside meadow (RL top image) and through fence on RR (Second image). Slip/Trip/Fall scenarios are more likely to be realised than swim/in water harm at this location.</p>

<p>Principle hazards observed</p> <p><u>Water</u></p> <ul style="list-style-type: none"> (i)Sluice structure - fall/height (ii) Culverts/tunnels (iii) Weir (iv) Deeper cold water. 	<p><u>Other</u></p> <ul style="list-style-type: none"> (i) Steps STF on RL (ii) Height and remains of sluice structure. (iii) Signs of alcohol use adjacent to sluice.

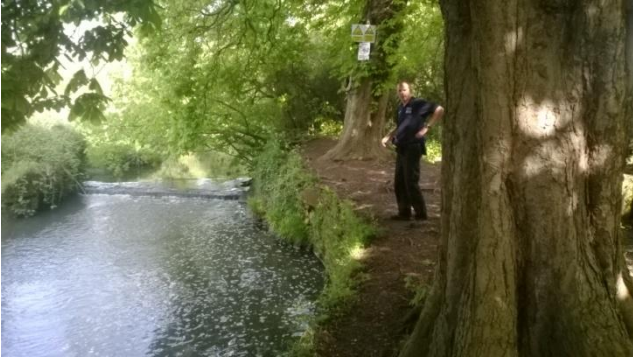
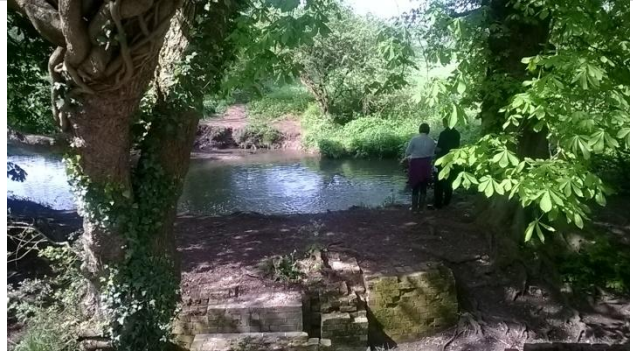
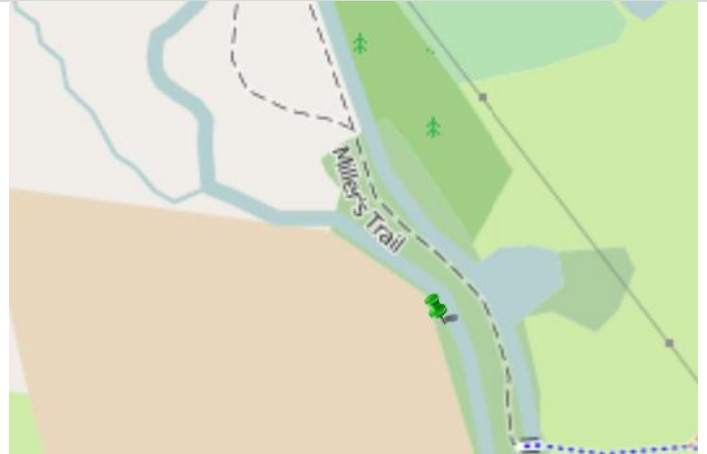
Paper Mill Weir (#3 and Appendix 1) is the scene of the last fatality and has a history of significant near misses. The combination of flowing, recirculating cold water, steep sided walls and very easy access from the footpath and main entrance points combined, with the presence of a weir and what - on the surface - looks to be a benign swimming/play spot, rates as a 'High risk' location. Further, at this location there are numerous slip/fall hazards: a broken leg or serious impact injury is also very likely.

# 3	Paper Mill Weir, River Arrow CP, Redditch	High	79
<p><u>Description:</u> Linear River Arrow section adjacent to footpath and fishing lake (>5metres). Small weir, deep pool with high freeboard on RL and beach on R.R. Known play and swimming spot. Obstructions in river both up and downstream. Culvert and mill working still present. Part of Scheduled Ancient Monument (SAM).</p> <p><u>Incident history:</u> Mar 2014: One fatality and rescuers in water. June-13: Near miss - Multiple person 'rescue' in water TBC. Probable high use and low confidence of reports.</p> <p><u>Mitigation options:</u> S/M term: Install barriers from footpath, indicate change in area from path. Possible PRE + Interpretive signs (see discussion). Long term: Package to re- profile location.</p> <p><u>Other comments:</u> Section is 250m downstream of 'Five Tunnels' consider both spots together when possible. i.e. public safety/order and design approaches.</p>

<p>Principle hazards observed</p> <p><u>Water</u></p> <ul style="list-style-type: none"> (i) Moving water (ii) Temperature (iii) Depth/Gradient (iv) Egress (iv) Proximity to footpath.(via) <p>High freeboard on RL bank.</p>	<p><u>Other</u></p> <p>(I) Numerous STF features i.e. Roots, old brickwork, mixed ambient lighting.</p>

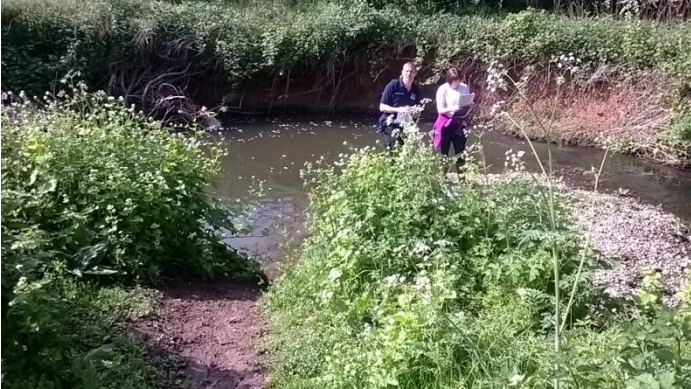
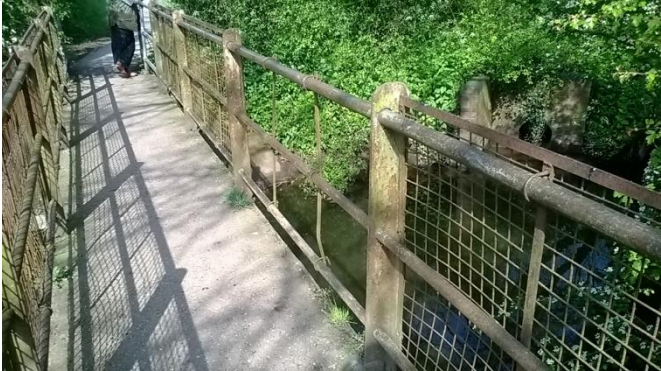
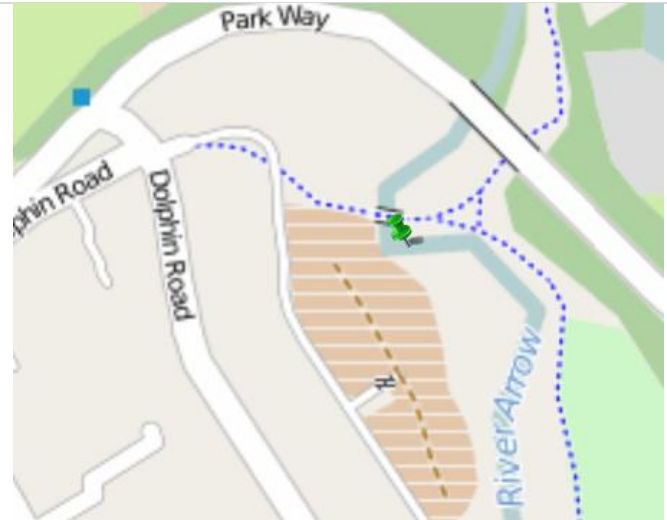
# 4	Abbeydale (Dolphin Rd Allotments), R.Arrow		Increased risk	58
<p><u>Description:</u> Meandering 'natural' River Arrow section. Small dogleg through 70degrees, debris along outer RR bank, inner section pebbles/silt creating small beach. Footbridge upstream linking footpath adjacent to allotments. Planting covers majority of bank side, save small desire line. High footfall area and cycle users, desire line seems to be people taking dogs to the water.</p> <p><u>Incident history:</u> Inconclusive. Possible: high footfall in vicinity and desire line. Low confidence of reports.</p> <p><u>Mitigation options:</u> (i) Periodic monitoring and snag fixes. (ii) Watercourse clearing as part of flood mitigation approaches. (iii) Bridge snag/repair.</p> <p><u>Other comments:</u> Works planned (County Council) to upgrade bridge. At high water levels, bridge is partly covered.</p>

<p>Principle hazards observed</p> <p><u>Water</u></p> <ul style="list-style-type: none"> (i) Moving water (ii) Temperature (iii) Depth/Gradient (iv) Egress (iv) Obstruction above/below water line. 	<p><u>Other</u></p> <ul style="list-style-type: none"> (i) Footbridge missing infill section, barrier still intact.

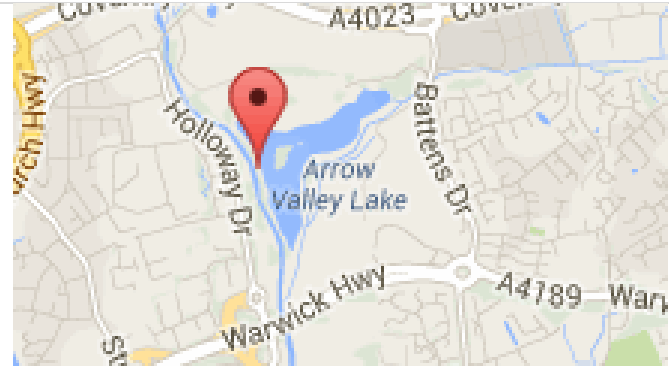
# 7	Arrow Valley Lake CP, Redditch		Lower risk	34
<p>Description: High use visitor location, large lake with footpaths, visitor centre, fishing pegs. Overhead power line across one section (adjacent to centre). Large play area nearby. Lake is well managed with natural sections of planting/grading along with barriers placed along several key points. Footpaths are set back in the main, well lit and flat. River Arrow runs parallel to western lake edge. Watersports activity and lifesaving club on site.</p> <p>Incident history: Inconclusive. Probable high use and low confidence of reports.</p> <p>Mitigation options: (i) Ongoing monitoring and snag fixing.</p> <p>Other comments: Principle site in country park. Main issues will result primarily from volume of users rather particular hazards on site.</p>		 		
<p>Principle hazards observed</p> <p><u>Water</u></p> <ul style="list-style-type: none"> (i) Depth/Temperature (ii) Volume of users (iii) User behaviours on/near water (iv) Adjacent weirs on River Arrow. 	<p><u>Other</u></p> <ul style="list-style-type: none"> (i) Power line overhead with fishing pegs in vicinity (signage in situ).

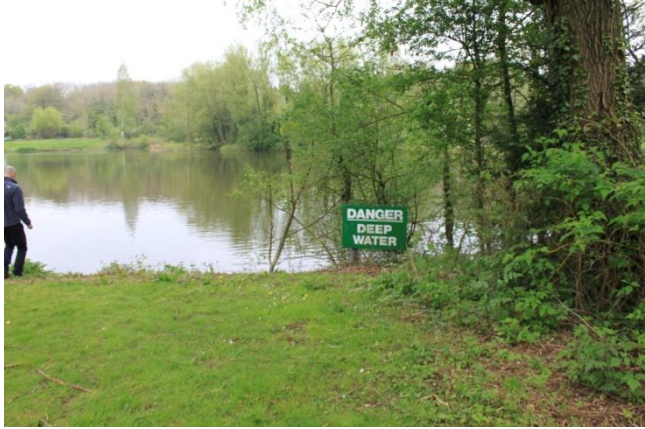
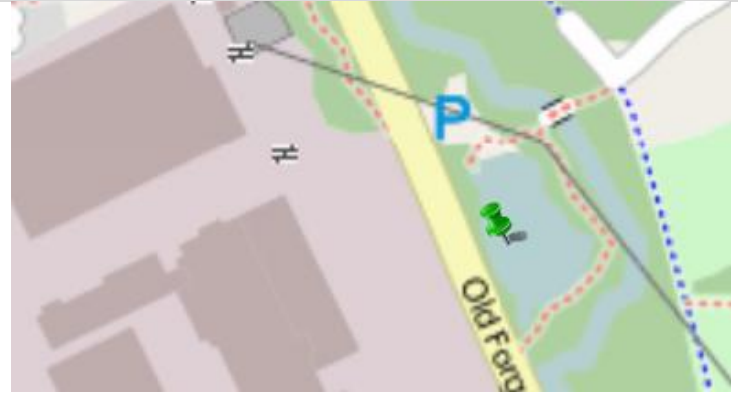
# 9	Ipsley Pool		Lower risk	39
<p><u>Description:</u> Small lake with fishing peg and footpath around. Adjacent to R. Arrow. Fishing peg on northern aspect, deeper meadow area on southern aspect, 'deep water' sign in situ. Ambient lighting good, road light also along SW aspect.</p> <p><u>Incident history:</u> Inconclusive. Possible - with low confidence of reports.</p> <p><u>Mitigation options:</u> (i) Ongoing monitoring (ii) Consider improving interpretive signage as part of wider borough work.</p> <p><u>Other comments:</u> Nice location, principle hazards are power line and slip/fall issues. Water safety issues arise from nearby R. Arrow (site #9.1). Observed some 20 cars parked onsite during the approx 1.5 hour visit.</p>

<p>Principle hazards observed</p> <p><u>Water</u></p> <p>(i) Depth on southern meadow aspect</p> <p>(ii) Access to River Arrow mill section.</p>	<p><u>Other</u></p> <p>(i) <u>Over head power line near</u> to car park and footpath - close to fishing peg.</p> <p>(ii) Signs of drug use in locality. (iii) STF hazards around step on southern edge</p> <p>(iv) Erosion of bank along aspect o f southern edge.</p>

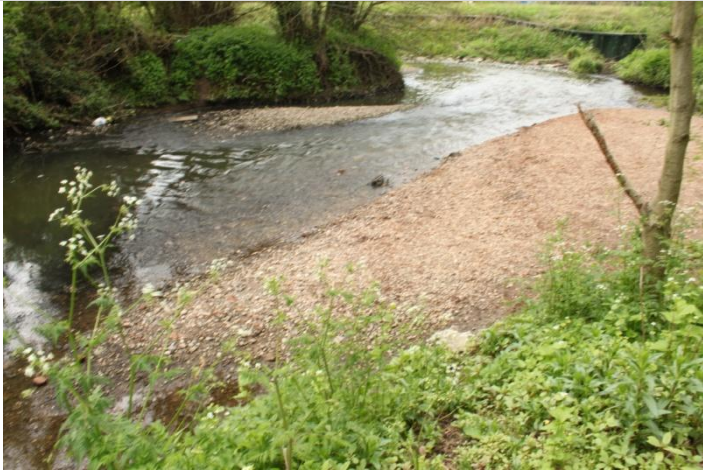
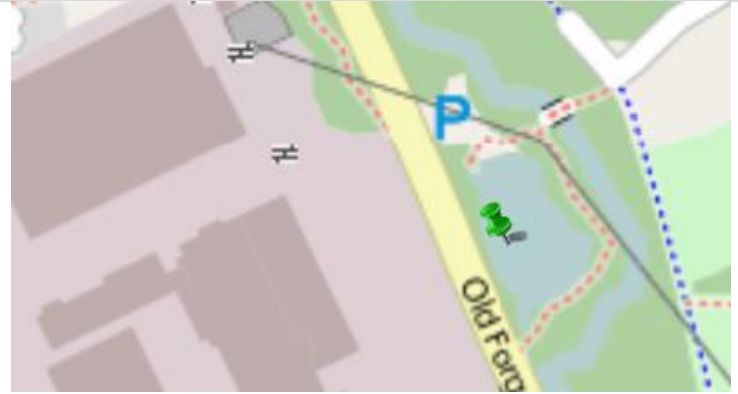
# 9.1	River Arrow (at Ipsley Pool)		Lower risk	50
	<p><u>Description:</u> Stretch of river running from reinforced bank at road section to bridleway and 'mill' workings. Post and rail placed alongside river bank at key locations.</p> <p><u>Incident history:</u> Inconclusive. Possible - with low confidence of reports.</p> <p><u>Mitigation options:</u> (i) Ongoing monitoring (ii) Consider improving interpretive signage as part of wider borough work.</p> <p><u>Other comments:</u> As per Ipsey Pool - principle hazard is power line and slip/fall issues. Observed some 20 cars parked onsite during the approx 1.5 hour visit.</p>

<p>Principle hazards observed</p> <p><u>Water</u></p> <p>(i) Current</p> <p>(ii) Obstructions downstream</p> <p>(iii) Temp</p> <p>(iv) Falls from bankside at mill</p>	<p><u>Other</u></p> <p>(i) Falls form bankside</p> <p>(ii) Over head power line near_to car park and footpath - close to fishing peg.</p>

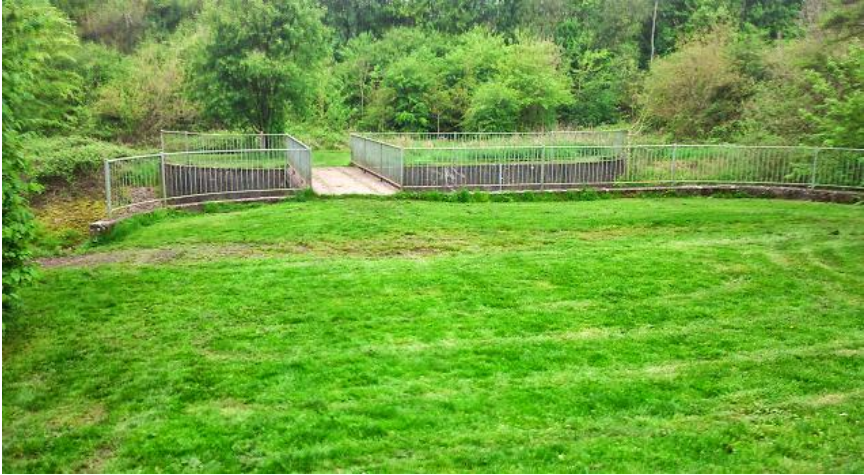
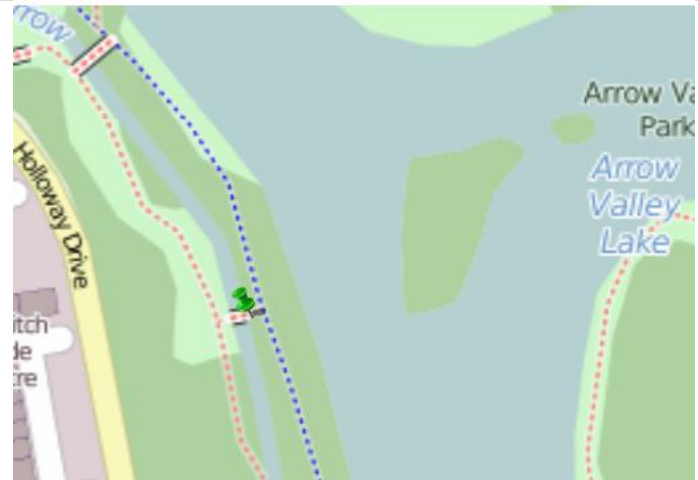
# 8	Middle Weir, R. Arrow CP	Increased risk	59
<p><u>Description:</u> Enclosed triangular weir with approx 2500mm concrete freeboard, surrounded by 1100mm flared balustrade. Weir is 2 of 3 along this linear stretch originally designed to take energy out of the river along this canalised section. Situated at W edge of lake, set back in meadow. No significant sign of swimming, although grass cut back on day of visit. No warning sign on location, equally no obvious sign of play/swim in vicinity.</p> <p><u>Incident history:</u> Inconclusive. Unlikely - with low confidence of reports.</p> <p><u>Mitigation options:</u> S/M term: Monitor. Long term: Remove as part of wider package of work to remodel flow and reinstated natural flow section using nearby brook.</p> <p><u>Other comments:</u> No swimming sign not present - logical as no sign of swimming at this location verses Lower Weir. All three weirs should be considered as part of possible engineering package. <u>Note:</u> Assessment of risk will change in higher/rising levels. Most likely that key at risk group are staff assessing/maintaining.</p>

<p>Principle hazards observed</p> <p><u>Water</u></p> <ul style="list-style-type: none"> (i) Hydraulic jump ('slot') at critical (undetermined) water levels. (ii) Depth and current below hydraulic (iii) Temperature (iv) Recirculation currents 	<p><u>Other</u></p> <p>None noted.</p>

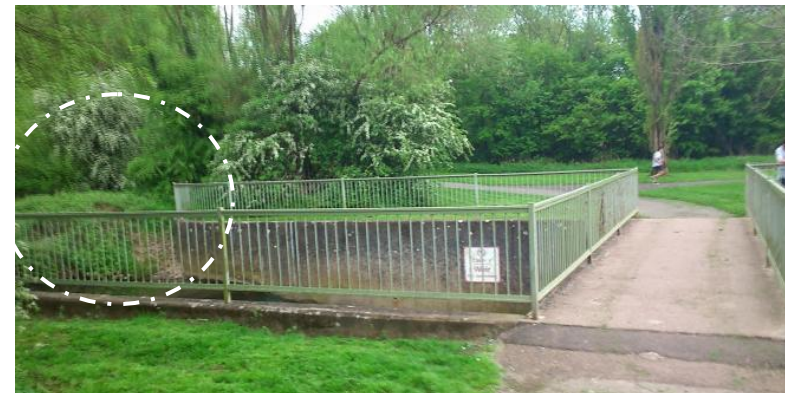
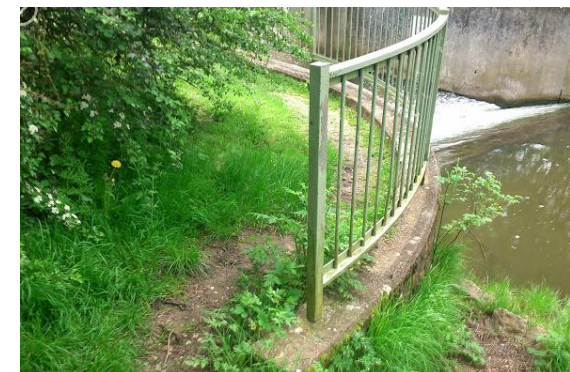
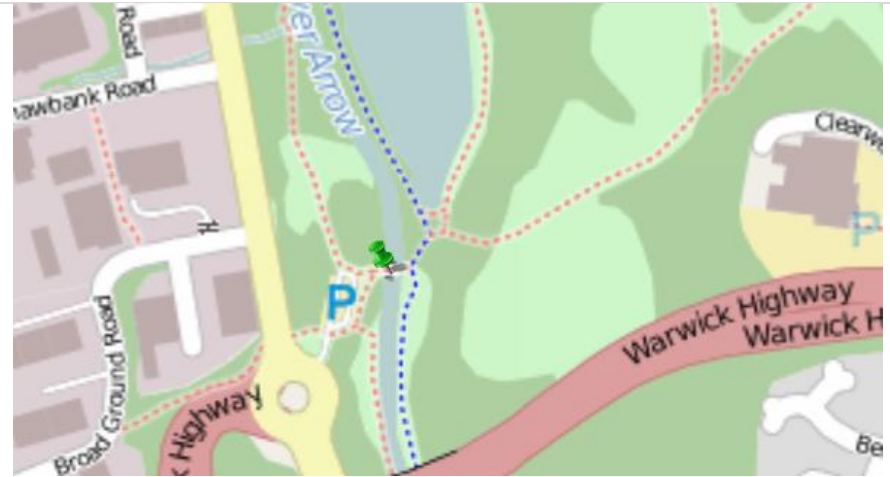
8.1 Lower Weir, R. Arrow, Near Broad Ground CP

Lower Weir' (#8.1) at a score of 67 is on the cusp of a 'High risk' location rating; this is due to the presence of teenagers and use in the locality, aligned with potentially dangerous water conditions. Weirs can present unique challenges due to the non-obvious recirculating nature of the currents, further they can and do regularly escalate into multiple casualty events.

Description: Enclosed triangular weir with approx 2500mm concrete freeboard, surrounded by 1100mm flared balustrade. Access via 'Broad Road' car park or SE lake footpath. Bridleway adjacent to location leading towards basketball court and underpass, and housing estate. Weir is 3 of 3 along this linear stretch originally designed to take energy out of the river along this canalised section. Lots of footfall over bridge and signs of play at both RR downstream bank and critically RL upstream (above lip circled). Graffiti and worn areas (see images). No swimming sign and known (?) swimming spot.

Other comments: *Potentially very dangerous hydraulic at key water levels,* somewhat mitigated by bad weather. Worth assessing during/after peak flow to assess hydraulic risks. Critical period will be after higher water condition and nicer weather i.e. Visitors back on site immediately after rainy days. Note staff/maintenance risks as per middle weir.

- (i) Fall hazard on RR downstream wall (end of barrier).

Mitigation options: S/M term: Encourage no access marginal planting at upstream RL bank. Long term: Remove as part of wider package of work to remodel flow and reinstated natural flow section using xxx brook.

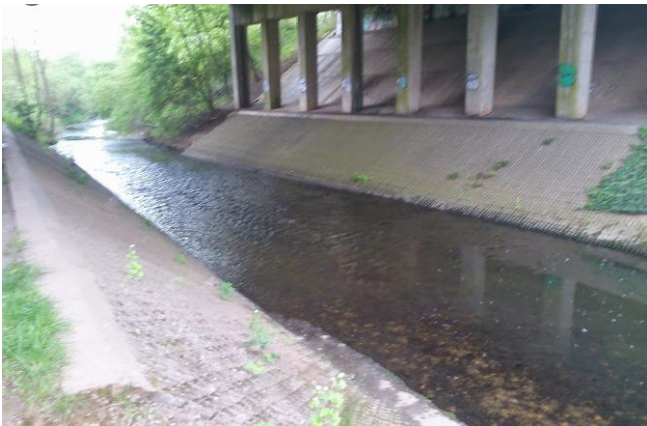
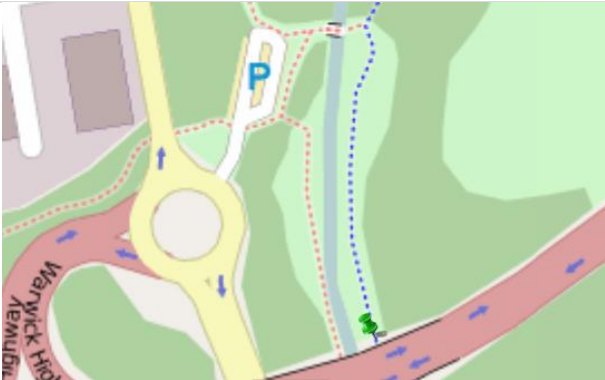
# 14	Arrow at Warwick highway underpass	Lower risk	40
<p><u>Description:</u> Basketball court adjacent to canalised section of river. Football set back some 5-8m from waterway. River section clear, no obstructions immediately up or downstream. Faster flowing water at higher flows.</p> <p><u>Incident history:</u> Fall/claim at location. Possible play spot.</p> <p><u>Mitigation options:</u> (I) Monitoring and site snagging.</p> <p><u>Other comments:</u> Useful location for allowing teens to congregate. Near to monitor impact of this in relation to 'Lower weir' (Site #8.1).</p>

<p>Principle hazards observed</p> <p><u>Water</u></p> <ul style="list-style-type: none"> (i) Variable current (ii) Canalised river (iii) Temp (iv) Play site adjacent 	<p><u>Other</u></p> <ul style="list-style-type: none"> (i) Underpass, known congregation sue for drinking (ii) Underpass 'floods' are STF issues

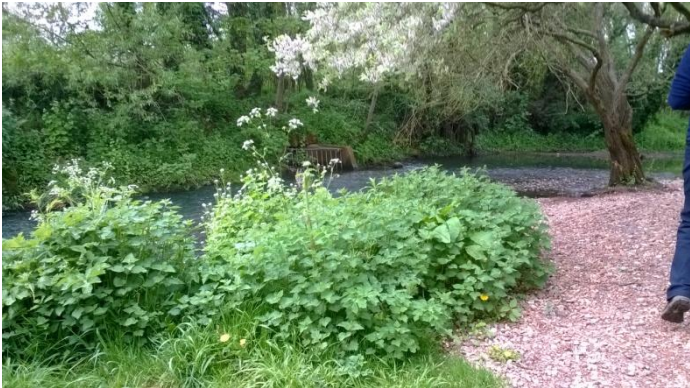
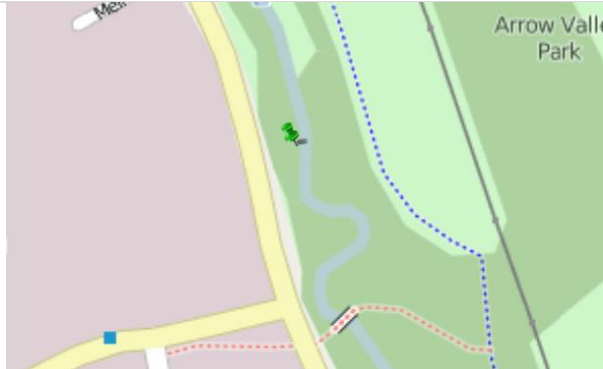
'Ispley Beach' (#10) scores 61, this is mostly due to the obvious presence of visitors at the location, the environment on the review day was relatively benign due to shallow gradients, good site vista and hazards that can be seen/understood by most visitors.

# 10	'Beach' South of Ipsley Pool	Increased risk	61
<p><u>Description:</u> Dogleg section of River Arrow. Path leading down to beach/wooded area. River doglegs through some 70degrees in section. Steep bank on RR, beach on RL. Pools of deeper water with base current through, fallen trees and obstruction above and below waterline. Pleasant 'beach' space above with (which will flood?) during higher flows. Known play, visit and swimming spot. Close to bridleway and route to pool.</p> <p><u>Incident history:</u> Inconclusive. Probable high use location and low confidence of reports.</p> <p><u>Mitigation options:</u> (I) Ongoing monitoring (ii) Clearing watercourse (iii) Possible education / interpretive information i.e.. You are here.</p> <p><u>Other comments:</u> Pleasant location with good views form land side. Paths lead to location and is obviously a known visitor spot.</p>

<p>Principle hazards observed</p> <p><u>Water</u></p> <p>(i) Deeper, flowing water</p> <p>(ii) Temperature</p> <p>(iii) Obstruction above/below waterline</p>	<p><u>Other</u></p> <p>(iv) Visitor behaviours.</p>

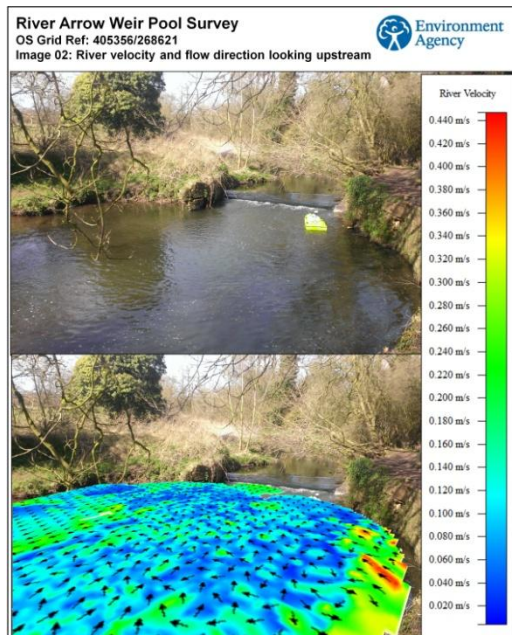
This shows the average velocity at any given point. Velocities are generally relatively low, apart from a section on the near bank which is approaching 0.45 m/s. The arrows show evidence of considerable radial flow patterns (backwards and circular flows), especially so on the bank near the camera. The highest measured velocity is directed backwards towards the weir.

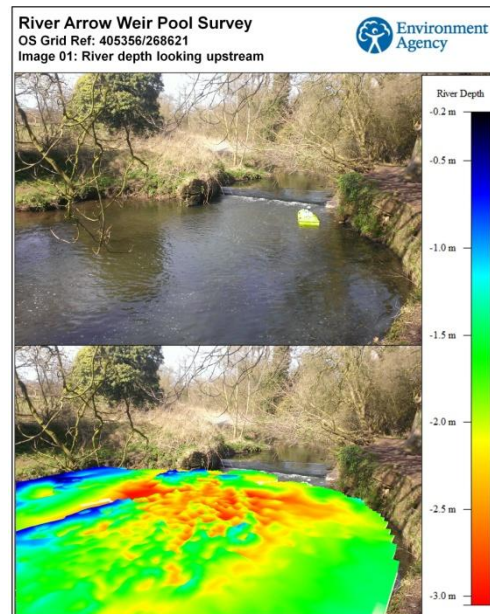
The river seems relatively benign, however the depth in the weir pool exceeds 3m with some particularly deep voids in the river bed. Within the visible section in image 1, the river is generally deeper than 1.5m however there is a narrow section (well away from the banks) which is perhaps only knee deep and then falls away into a 3m deep pool on approach to the weir.

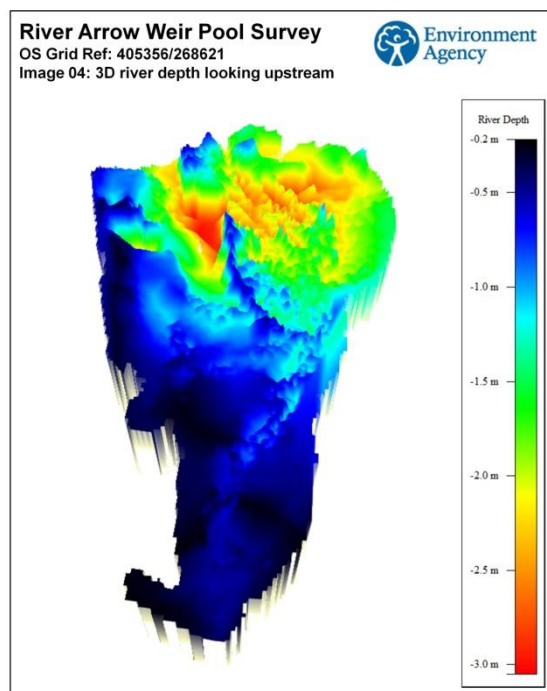
This is a 3D view looking upstream. Again it shows the relatively shallow water at the downstream entry point with deep water in the weir pool.

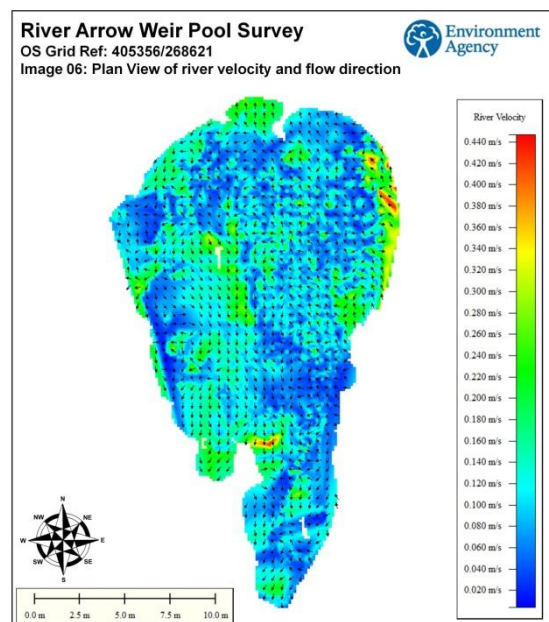
This a plan view (looking down from above) showing the river velocity and direction. It shows evidence of a very confused flow pattern in the deep weir pool. The arrows should generally align in the direction of the river flow (as they do in the bottom half of the image), however in the weir pool the river is demonstrating whirl pool characteristics with no clear direction of travel. The radial flow patterns show a re-circulation back towards the weir, and the force of this would likely attract floating objects back towards the weir.
