**The Royal Society for the Prevention  
of Accidents**

Water Safety Review for:  
**Redditch Borough Council**

**April 2014**

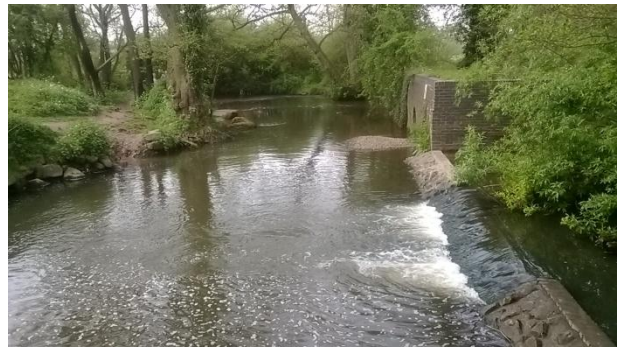
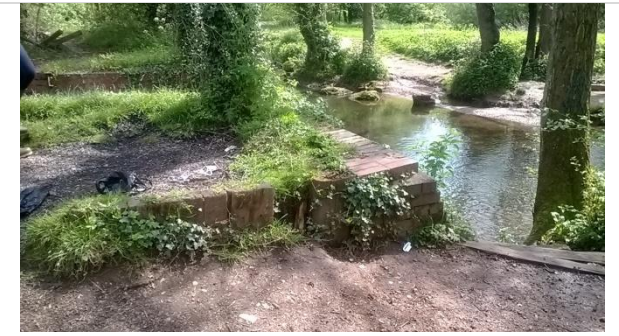
**Five Tunnels (#1)** had multiple hazards in close proximity including a weir, sluice and is a known swimming spot. There is also signs of vandalism/fire and alcohol use. In addition to the water hazards, falls from height into water/objects is a significant factor at this location.

- (i) Steps STF on RL
- (ii) Height and remains of sluice structure.
- (iii) Signs of alcohol use adjacent to sluice.

Mitigation options: (i)S/M term: maintain monitoring and information regime. (ii) Longer term: Possible package of work to re-profile weir and sluice.

Other comments: Difficult site to effectively mitigate. Need to consider access from both waterside meadow (RL top image) and through fence on RR (Second image). Slip/Trip/Fall scenarios are more likely to be realised than swim/in water harm at this location.

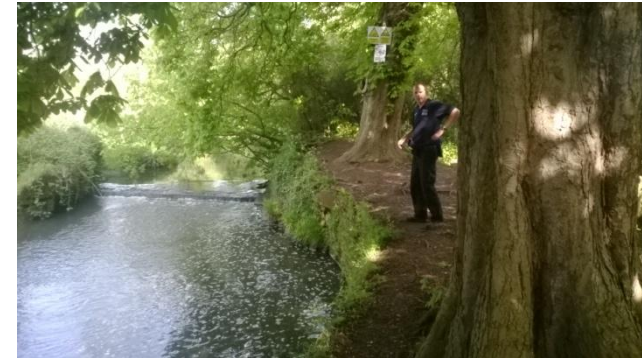
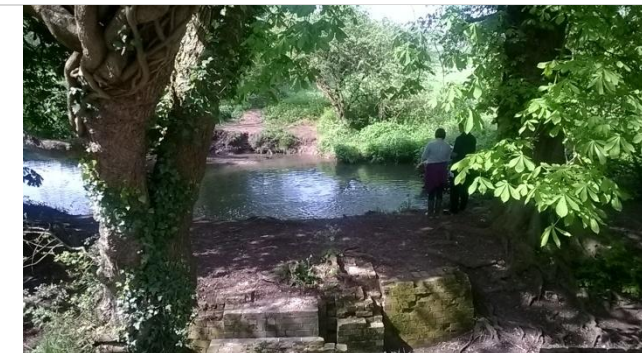
**# 3** Paper Mill Weir, River Arrow CP, Redditch

**Paper Mill Weir (#3 and Appendix 1)** is the scene of the last fatality and has a history of significant near misses. The combination of flowing, recirculating cold water, steep sided walls and very easy access from the footpath and main entrance points combined, with the presence of a weir and what - on the surface - looks to be a benign swimming/play spot, rates as a 'High risk' location. Further, at this location there are numerous slip/fall hazards: a broken leg or serious impact injury is also very likely.

(I) Numerous STF features i.e. Roots, old brickwork, mixed ambient lighting.

Mitigation options: S/M term: Install barriers from footpath, indicate change in area from path. Possible PRE + Interpretive signs (see discussion). Long term: Package to re- profile location.

Other comments: Section is 250m downstream of 'Five Tunnels' consider both spots together when possible. i.e. public safety/order and design approaches.

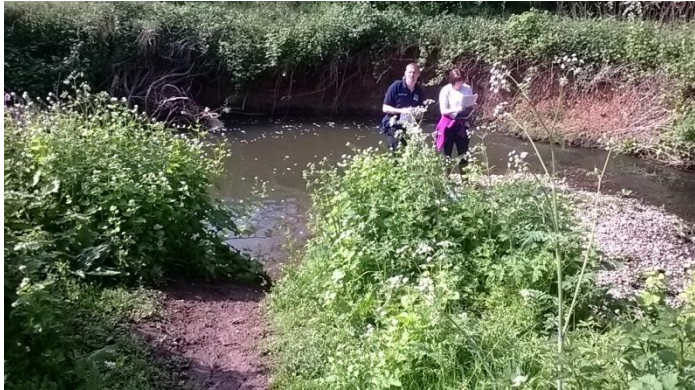
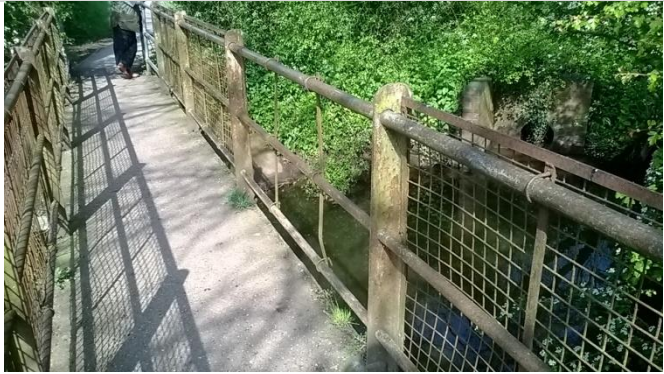
**# 4**      **Abbeydale (Dolphin Rd Allotments), R.Arrow**

Other comments: Works planned (County Council) to upgrade bridge. At high water levels, bridge is partly covered.

- (i) Footbridge missing infill section, barrier still intact.

Mitigation options: (i) Periodic monitoring and snag fixes. (ii) Watercourse clearing as part of flood mitigation approaches. (iii) Bridge snag/repair.

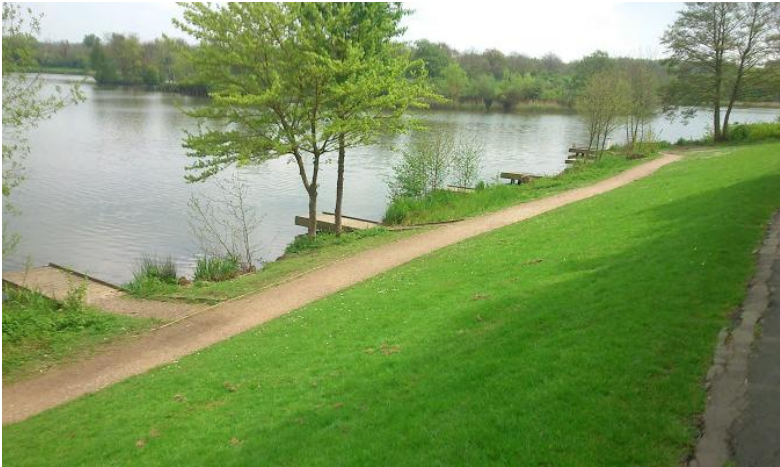
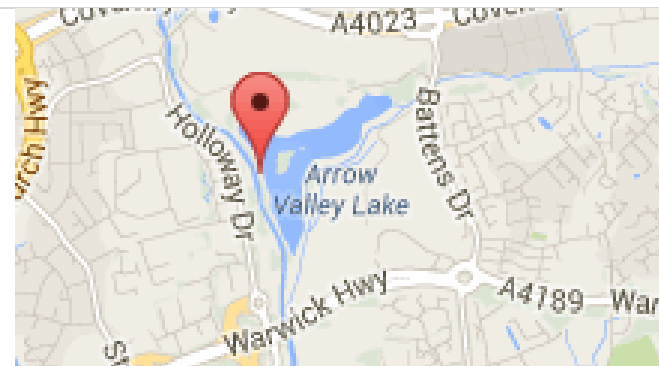
**# 7** Arrow Valley Lake CP, Redditch

Other comments: Principle site in country park. Main issues will result primarily from volume of users rather particular hazards on site.

Mitigation options: (i) Ongoing monitoring and snag fixing.

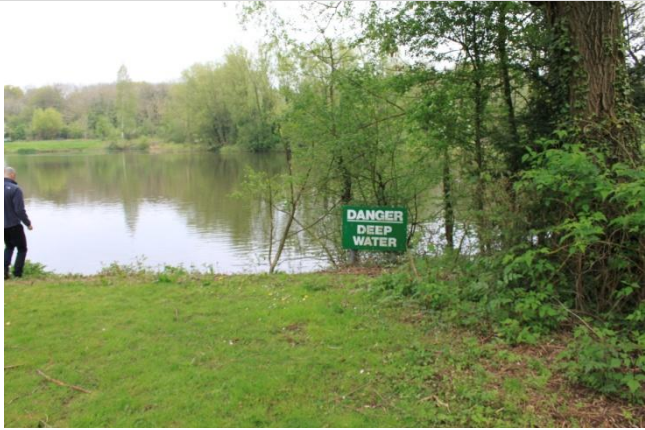
# 9	<b>Ipsley Pool</b>	<b>Lower risk</b>	<b>39</b>
<p><u>Description:</u> Small lake with fishing peg and footpath around. Adjacent to R. Arrow. Fishing peg on northern aspect, deeper meadow area on southern aspect, 'deep water' sign in situ. Ambient lighting good, road light also along SW aspect.</p> <p><u>Incident history:</u> Inconclusive. Possible - with low confidence of reports.</p> <p><u>Mitigation options:</u> (i) Ongoing monitoring (ii) Consider improving interpretive signage as part of wider borough work.</p> <p><u>Other comments:</u> Nice location, principle hazards are power line and slip/fall issues. Water safety issues arise from nearby R. Arrow (site #9.1). Observed some 20 cars parked onsite during the approx 1.5 hour visit.</p>

<p><b>Principle hazards observed</b></p> <p><u>Water</u></p> <p>(i) Depth on southern meadow aspect (ii) Access to River Arrow mill section.</p>	<p><u>Other</u></p> <p>(i) <u>Over head power line near to car park and footpath - close to fishing peg.</u> (ii) Signs of drug use in locality. (iii) STF hazards around step on southern edge (iv) Erosion of bank along aspect o f southern edge.</p>

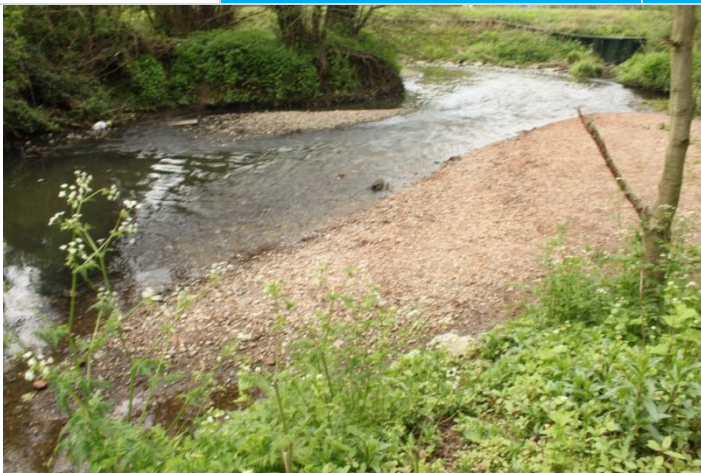
<b># 9.1</b>	<b>River Arrow (at Ipsley Pool)</b>	<b>Lower risk</b>	<b>50</b>
<p><u>Description:</u> Stretch of river running from reinforced bank at road section to bridleway and 'mill' workings. Post and rail placed alongside river bank at key locations.</p> <p><u>Incident history:</u> Inconclusive. Possible - with low confidence of reports.</p> <p><u>Mitigation options:</u> (i) Ongoing monitoring (ii) Consider improving interpretive signage as part of wider borough work.</p> <p><u>Other comments:</u> As per Ipsey Pool - principle hazard is power line and slip/fall issues. Observed some 20 cars parked onsite during the approx 1.5 hour visit.</p>

<p><b>Principle hazards observed</b></p> <p><u>Water</u></p> <ul style="list-style-type: none"> <li>(i) Current</li> <li>(ii) Obstructions downstream</li> <li>(iii) Temp</li> <li>(iv) Falls from bankside at mill</li> </ul>	<p><u>Other</u></p> <ul style="list-style-type: none"> <li>(i) Falls form bankside</li> <li>(ii) Over head power line near_to car park and footpath - close to fishing peg.</li> </ul>

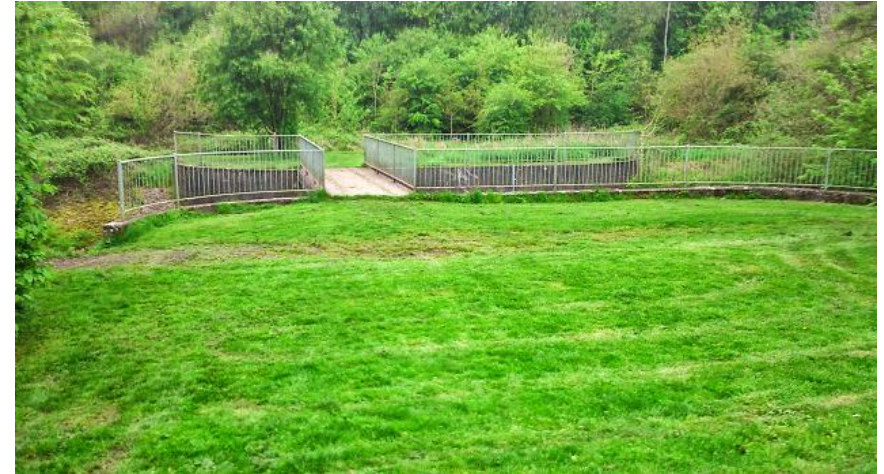
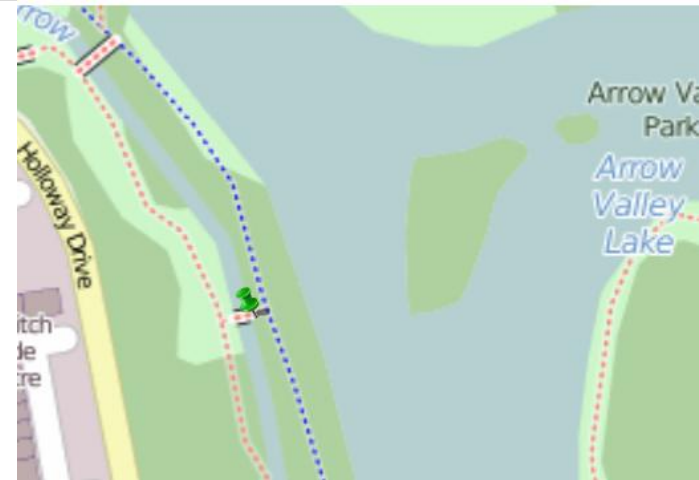
**# 8 Middle Weir, R. Arrow CP**

Other comments: No swimming sign not present - logical as no sign of swimming at this location verses Lower Weir. All three weirs should be considered as part of possible engineering package. Note: Assessment of risk will change in higher/rising levels. Most likely that key at risk group are staff assessing/maintaining.

Mitigation options: S/M term: Monitor. Long term: Remove as part of wider package of work to remodel flow and reinstated natural flow section using nearby brook.

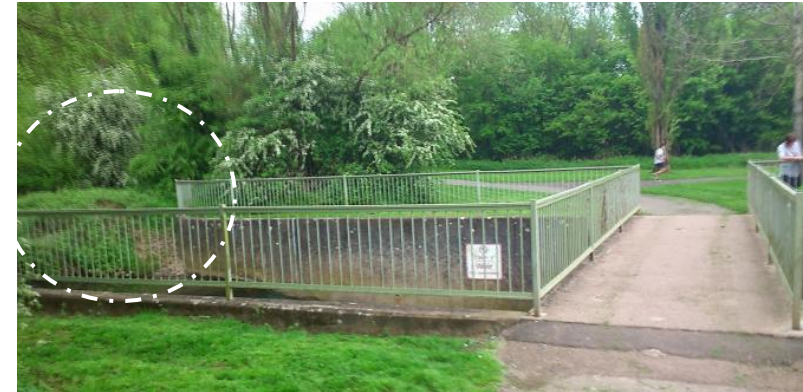
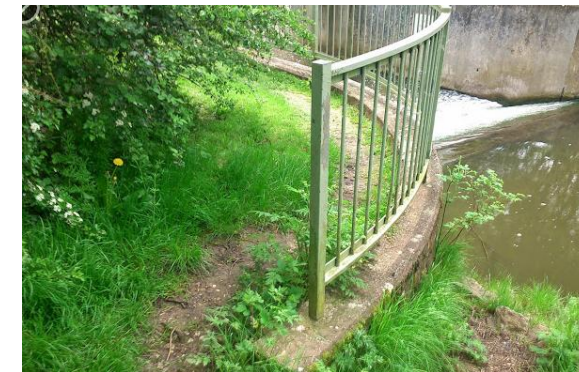
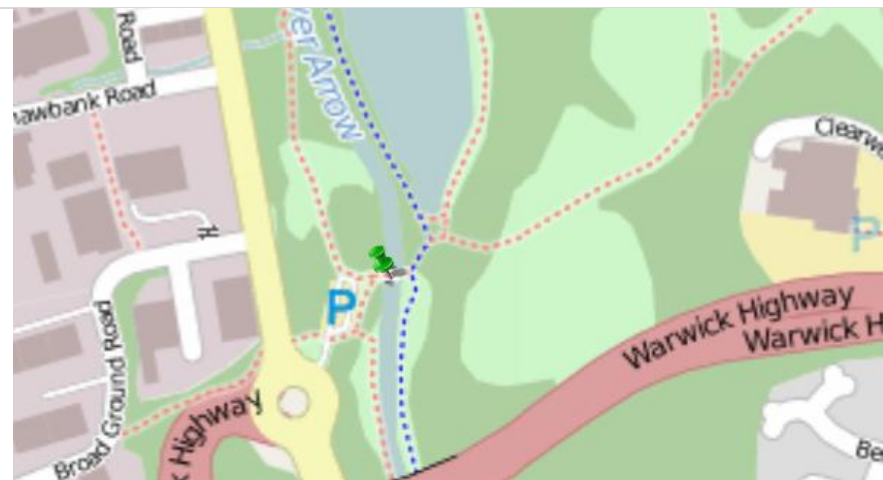
## # 8.1 Lower Weir, R. Arrow, Near Broad Ground CP

**Lower Weir' (#8.1)** at a score of 67 is on the cusp of a 'High risk' location rating; this is due to the presence of teenagers and use in the locality, aligned with potentially dangerous water conditions. Weirs can present unique challenges due to the non-obvious recirculating nature of the currents, further they can and do regularly escalate into multiple casualty events.

**Description:** Enclosed triangular weir with approx 2500mm concrete freeboard, surrounded by 1100mm flared balustrade. Access via 'Broad Road' car park or SE lake footpath. Bridleway adjacent to location leading towards basketball court and underpass, and housing estate. Weir is 3 of 3 along this linear stretch originally designed to take energy out of the river along this canalised section. Lots of footfall over bridge and signs of play at both RR downstream bank and critically RL upstream (above lip circled). Graffiti and worn areas (see images). No swimming sign and known (?) swimming spot.

**Other comments:** *Potentially very dangerous hydraulic at key water levels,* somewhat mitigated by bad weather. Worth assessing during/after peak flow to assess hydraulic risks. Critical period will be after higher water condition and nicer weather i.e. Visitors back on site immediately after rainy days. Note staff/maintenance risks as per middle weir.

- (i) Fall hazard on RR downstream wall (end of barrier).

**Mitigation options:** S/M term: Encourage no access marginal planting at upstream RL bank. Long term: Remove as part of wider package of work to remodel flow and reinstated natural flow section using xxx brook.

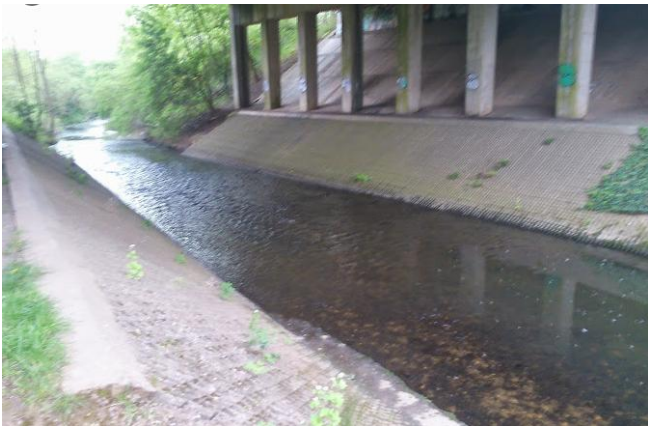
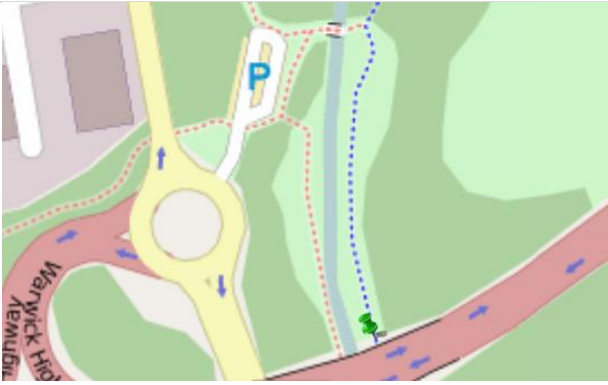
<b># 14</b>	<b>Arrow at Warwick highway underpass</b>	<b>Lower risk</b>	<b>40</b>
-------------	---	-------------------	-----------

**Description:** Basketball court adjacent to canalised section of river. Football set back some 5-8m from waterway. River section clear, no obstructions immediately up or downstream. Faster flowing water at higher flows.

**Other comments:** Useful location for allowing teens to congregate. Near to monitor impact of this in relation to 'Lower weir' (Site #8.1).

**Mitigation options:** (I) Monitoring and site snagging.

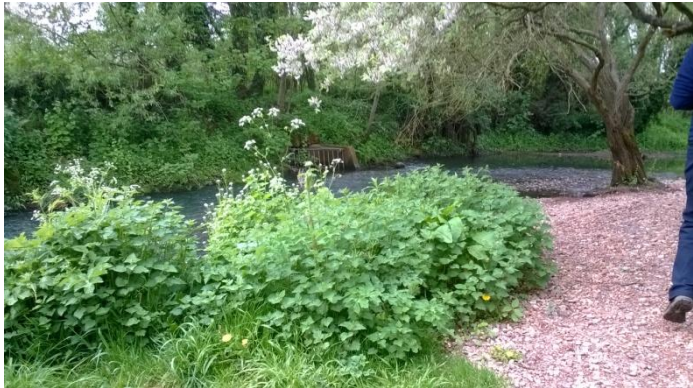
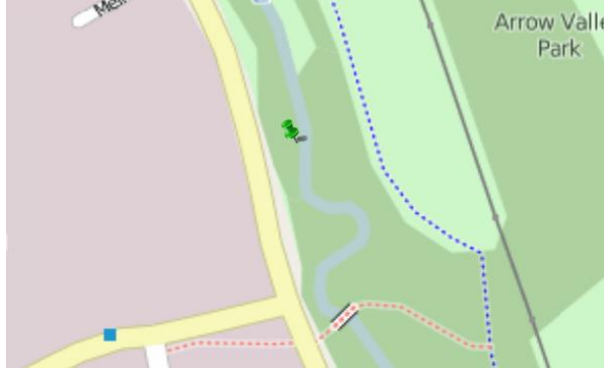
**# 10 'Beach' South of Ipsley Pool**

'Ispley Beach' (#10) scores 61, this is mostly due to the obvious presence of visitors at the location, the environment on the review day was relatively benign due to shallow gradients, good site vista and hazards that can be seen/understood by most visitors.

Description: Dogleg section of River Arrow. Path leading down to beach/wooded area. River doglegs through some 70degrees in section. Steep bank on RR, beach on RL. Pools of deeper water with base current through, fallen trees and obstruction above and below waterline. Pleasant 'beach' space above with (which will flood?) during higher flows. Known play, visit and swimming spot. Close to bridleway and route to pool.

**Principle hazards observed**  
Water  
 (i) Deeper, flowing water  
 (ii) Temperature  
 (iii) Obstruction above/below waterline

Mitigation options: (I) Ongoing monitoring (ii) Clearing watercourse (iii) Possible education / interpretive information i.e.. You are here.

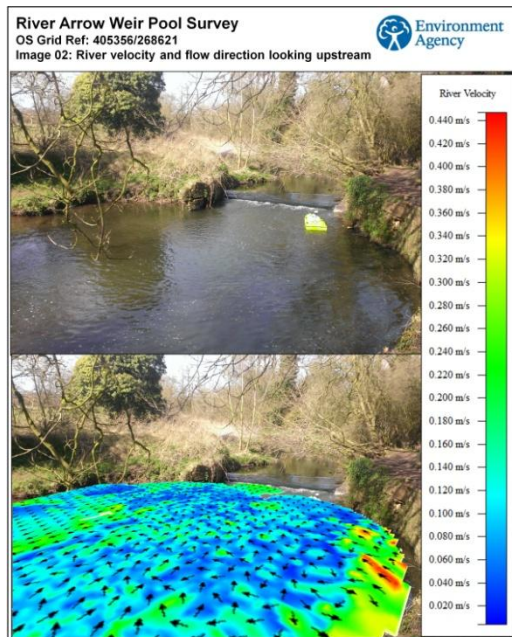
This shows the average velocity at any given point. Velocities are generally relatively low, apart from a section on the near bank which is approaching 0.45 m/s. The arrows show evidence of considerable radial flow patterns (backwards and circular flows), especially so on the bank near the camera. The highest measured velocity is directed backwards towards the weir.

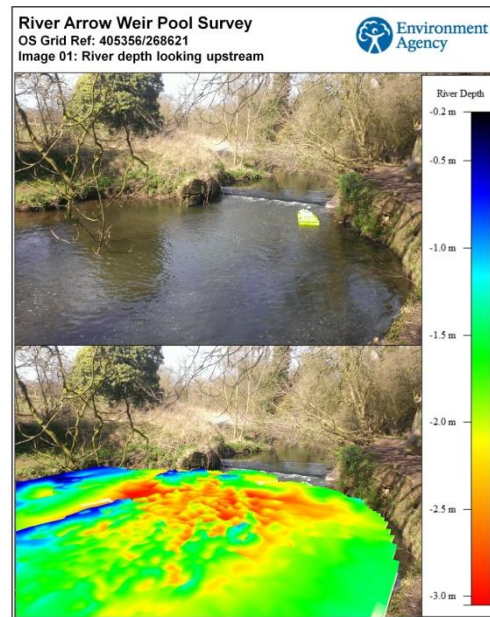
The river seems relatively benign, however the depth in the weir pool exceeds 3m with some particularly deep voids in the river bed. Within the visible section in image 1, the river is generally deeper than 1.5m however there is a narrow section (well away from the banks) which is perhaps only knee deep and then falls away into a 3m deep pool on approach to the weir.

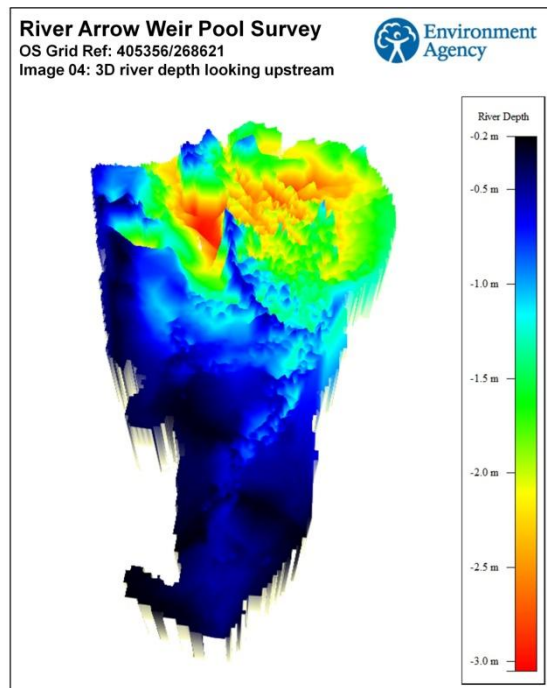
This is a 3D view looking upstream. Again it shows the relatively shallow water at the downstream entry point with deep water in the weir pool.

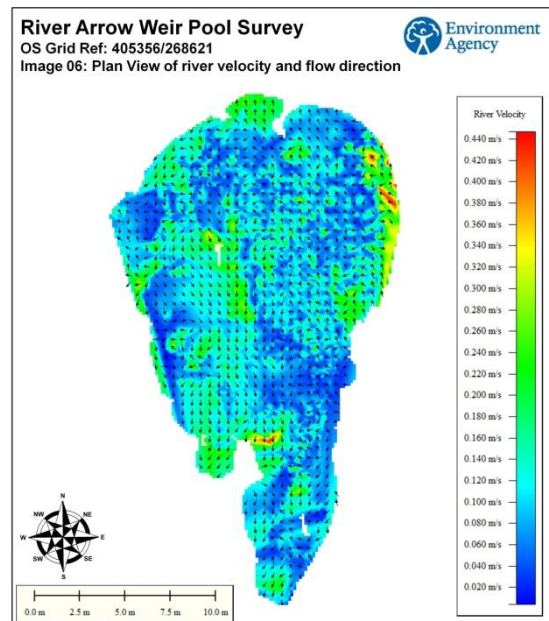
This a plan view (looking down from above) showing the river velocity and direction. It shows evidence of a very confused flow pattern in the deep weir pool. The arrows should generally align in the direction of the river flow (as they do in the bottom half of the image), however in the weir pool the river is demonstrating whirl pool characteristics with no clear direction of travel. The radial flow patterns show a re-circulation back towards the weir, and the force of this would likely attract floating objects back towards the weir.
