## 5. Arrow Valley Catchment Restoration Project (Pages 1 - 40)

Water Safety Review for:  
**Redditch Borough Council**

**April 2014**

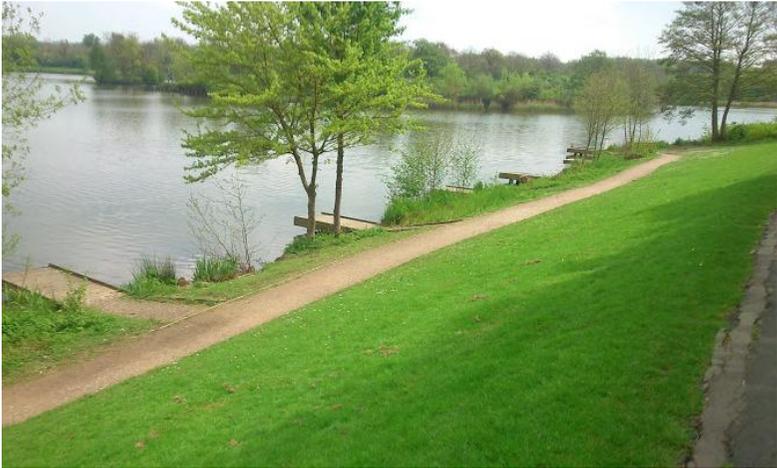
# 7	Arrow Valley Lake CP, Redditch	Lower risk	34
<p><u>Description:</u> High use visitor location, large lake with footpaths, visitor centre, fishing pegs. Overhead power line across one section (adjacent to centre). Large play area nearby. Lake is well managed with natural sections of planting/grading along with barriers placed along several key points. Footpaths are set back in the main, well lit and flat. River Arrow runs parallel to western lake edge. Watersports activity and lifesaving club on site.</p> <p><u>Incident history:</u> Inconclusive. Probable high use and low confidence of reports.</p> <p><u>Mitigation options:</u> (i) Ongoing monitoring and snag fixing.</p> <p><u>Other comments:</u> Principle site in country park. Main issues will result primarily from volume of users rather particular hazards on site.</p>

<p><b>Principle hazards observed</b></p> <p><u>Water</u></p> <ul style="list-style-type: none"> <li>(i) Depth/Temperature</li> <li>(ii) Volume of users</li> <li>(iii) User behaviours on/near water</li> <li>(iv) Adjacent weirs on River Arrow.</li> </ul>	<p><u>Other</u></p> <ul style="list-style-type: none"> <li>(i) Power line overhead with fishing pegs in vicinity (signage in situ).</li> </ul>

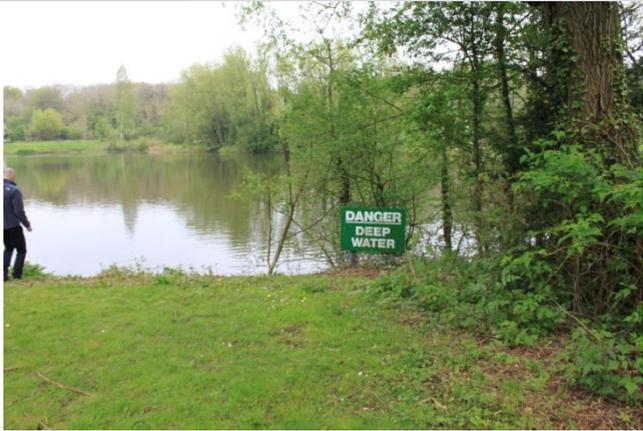
# 9	<b>Ipsley Pool</b>	Lower risk	39
<p><u>Description:</u> Small lake with fishing peg and footpath around. Adjacent to R. Arrow. Fishing peg on northern aspect, deeper meadow area on southern aspect, 'deep water' sign in situ. Ambient lighting good, road light also along SW aspect.</p> <p><u>Incident history:</u> Inconclusive. Possible - with low confidence of reports.</p> <p><u>Mitigation options:</u> (i) Ongoing monitoring (ii) Consider improving interpretive signage as part of wider borough work.</p> <p><u>Other comments:</u> Nice location, principle hazards are power line and slip/fall issues. Water safety issues arise from nearby R. Arrow (site #9.1). Observed some 20 cars parked onsite during the approx 1.5 hour visit.</p>

<p><b>Principle hazards observed</b></p> <p><u>Water</u></p> <p>(i) Depth on southern meadow aspect (ii) Access to River Arrow mill section.</p>	<p><u>Other</u></p> <p>(i) <u>Over head power line near</u> to car park and footpath - close to fishing peg. (ii) Signs of drug use in locality. (iii) STF hazards around step on southern edge (iv) Erosion of bank along aspect o f southern edge.</p>

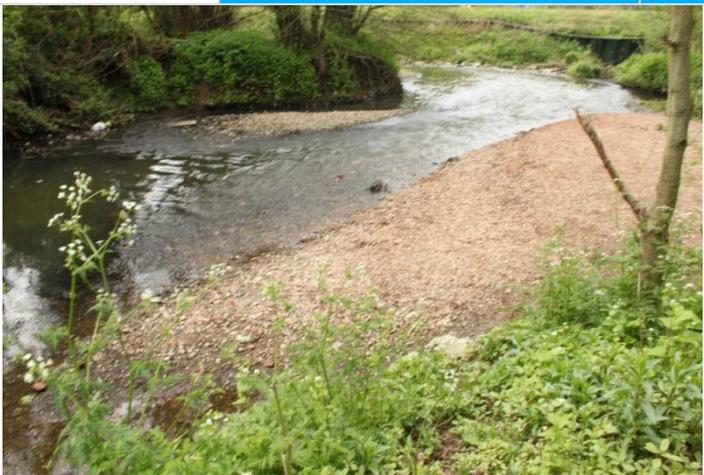
<b># 9.1</b>	<b>River Arrow (at Ipsley Pool)</b>	<b>Lower risk</b>	<b>50</b>
<p><u>Description:</u> Stretch of river running from reinforced bank at road section to bridleway and 'mill' workings. Post and rail placed alongside river bank at key locations.</p> <p><u>Incident history:</u> Inconclusive. Possible - with low confidence of reports.</p> <p><u>Mitigation options:</u> (i) Ongoing monitoring (ii) Consider improving interpretive signage as part of wider borough work.</p> <p><u>Other comments:</u> As per Ipsey Pool - principle hazard is power line and slip/fall issues. Observed some 20 cars parked onsite during the approx 1.5 hour visit.</p>

<p><b>Principle hazards observed</b></p> <p><u>Water</u></p> <ul style="list-style-type: none"> <li>(i) Current</li> <li>(ii) Obstructions downstream</li> <li>(iii) Temp</li> <li>(iv) Falls from bankside at mill</li> </ul>	<p><u>Other</u></p> <ul style="list-style-type: none"> <li>(i) Falls form bankside</li> <li>(ii) Over head power line near_to car park and footpath - close to fishing peg.</li> </ul>

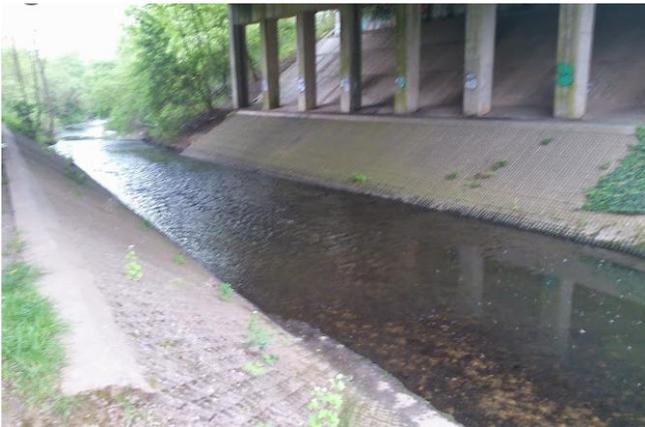
Other comments: Useful location for allowing teens to congregate. Near to monitor impact of this in relation to 'Lower weir' (Site #8.1).

**Principle hazards observed**

Mitigation options: (I) Monitoring and site snagging.
