**The Royal Society for the Prevention
of Accidents**

Water Safety Review for:
Redditch Borough Council

April 2014

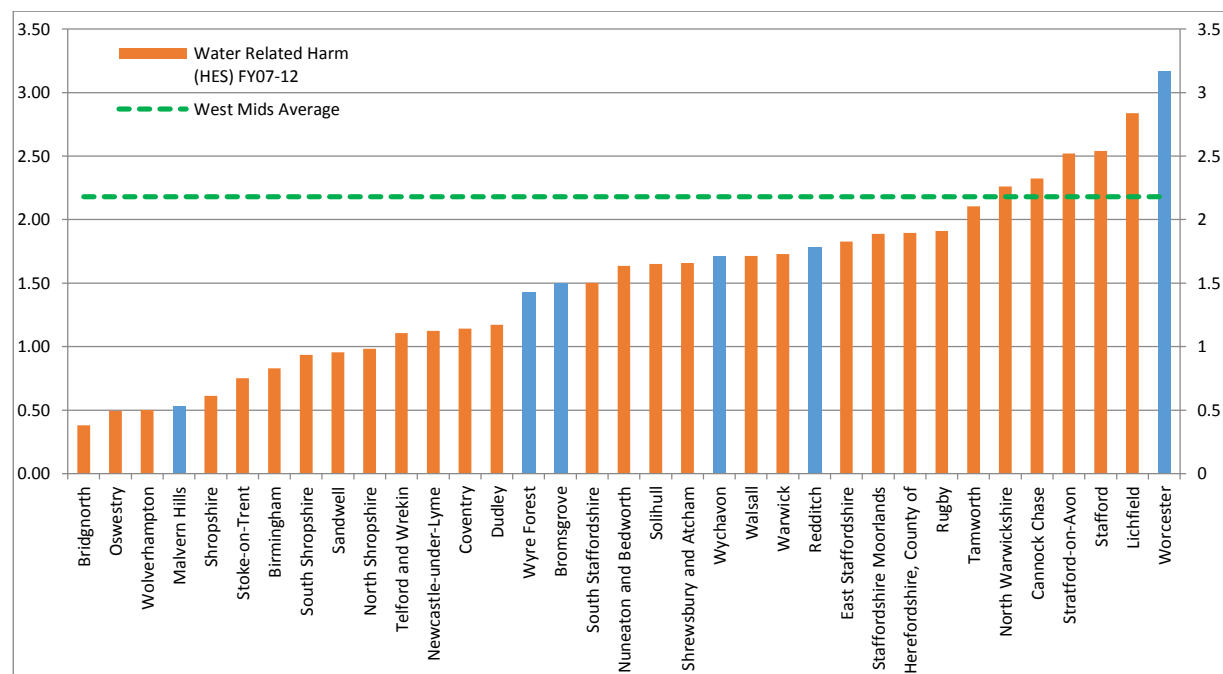
Figure 1: Rate of Water Related Harm Per 100,000 Residents in the West Midlands
(Hospital Episode Statistics, FY07-12)
(Note blue bars denotes Worcestershire Area)

There was 48 reported cases within the Worcestershire region, with Worcester city and Wychaven returning cases most frequently. There were 14 cases in Redditch or Bromsgrove. The most frequently used codes within the 48 cases were: (i) Unspecified (ii) Fall from cliff (iii) Other (iv) Dive/Jump injury...into water resulting harm other than drown/submersion (v) Drown/submersion into natural water.

The rate of water-related hospital episodes in Redditch sit moderately within the region and can be considered 'low' against other injuries (Figure 1). However given that drowning and water related harm often results in severe and long term outcomes these findings should not be taken as a sign for complacency.
