**The Royal Society for the Prevention  
of Accidents**

Water Safety Review for:  
**Redditch Borough Council**

**April 2014**

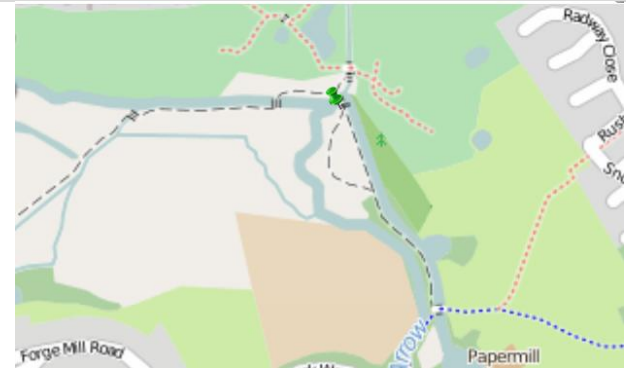
**# 3** Paper Mill Weir, River Arrow CP, Redditch

**High**

The river seems relatively benign, however the depth in the weir pool exceeds 3m with some particularly deep voids in the river bed. Within the visible section in image 1, the river is generally deeper than 1.5m however there is a narrow section (well away from the banks) which is perhaps only knee deep and then falls away into a 3m deep pool on approach to the weir.

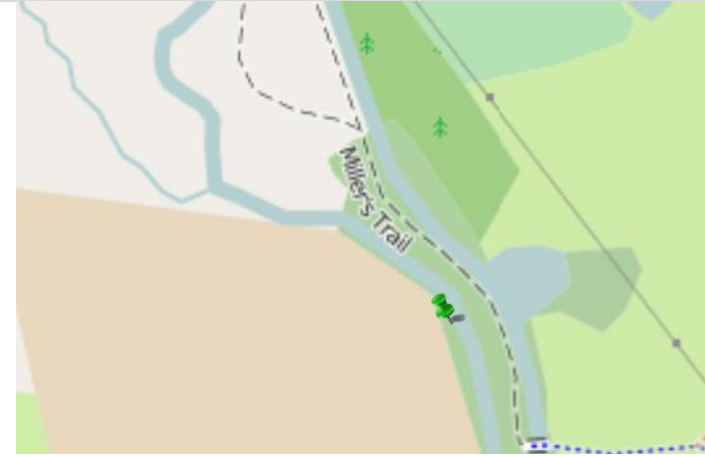
**# 4**      **Abbeydale (Dolphin Rd Allotments), R.Arrow**

**Increased risk**      **58**

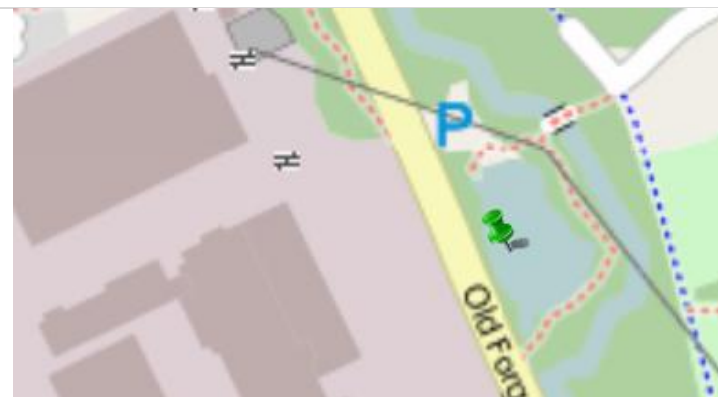
<b># 9.1</b>	<b>River Arrow (at Ipsley Pool)</b>	<b>Lower risk</b>	<b>50</b>
<p><u>Description:</u> Stretch of river running from reinforced bank at road section to bridleway and 'mill' workings. Post and rail placed alongside river bank at key locations.</p> <p><u>Incident history:</u> Inconclusive. Possible - with low confidence of reports.</p> <p><u>Mitigation options:</u> (i) Ongoing monitoring (ii) Consider improving interpretive signage as part of wider borough work.</p> <p><u>Other comments:</u> As per Ipsey Pool - principle hazard is power line and slip/fall issues. Observed some 20 cars parked onsite during the approx 1.5 hour visit.</p>
